Contract #: 04-0120F4Cty: SF/ALA Rte: 80 PM: 13.2/13.9File #: 69.28**WELDING INSPECTION REPORT****Resident Engineer:** Pursell, Gary**Address:** 333 Burma Road**City:** Oakland, CA 94607**Report No:** WIR-002195**Date Inspected:** 26-Apr-2008**Project Name:** SAS Superstructure**OSM Arrival Time:** 630**Prime Contractor:** American Bridge/Fluor Enterprises, a JV**OSM Departure Time:** 1530**Contractor:** Zhenhua Port Machinery Company, Ltd (ZPMC), Changxing Island **Location:** Shanghai, China**CWI Name:** Sun Wei**CWI Present:** Yes No**Inspected CWI report:** Yes No N/A**Rod Oven in Use:** Yes No N/A**Electrode to specification:** Yes No N/A**Weld Procedures Followed:** Yes No N/A**Qualified Welders:** Yes No N/A**Verified Joint Fit-up:** Yes No N/A**Approved Drawings:** Yes No N/A**Approved WPS:** Yes No N/A**Delayed / Cancelled:** Yes No N/A**Bridge No:** 34-0006**Component:** OBG**Summary of Items Observed:**

WELDING INSPECTION REPORT

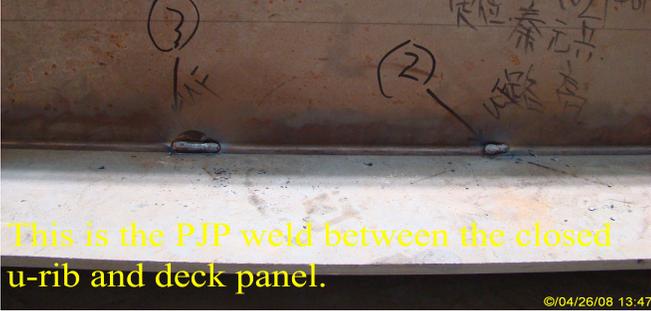
Typical weld repair of short visual imperfections (Under Fill UF) on weld joint DP013-001-006.

This is the PJP weld between the closed u-rib and deck panel.

This QAI observed ZPMC personnel preparing sites for weld repair of visual welding rejects on deck panel's DP013-001 and DP017-001 by grinding. In a conversation with the ZPMC Certified Welding Inspector (CWI) Sun Wei it was stated that welding should commence sometime this afternoon. The welder Xu Guo yin, welder identification 059443 conducted welding on 4 spots of deck panel weld DP013-001-006 where 2 locations were lack of fusion (LF) and 3 were under fill (UF), 4-UF & 5-UF. Essential variables were not captured.

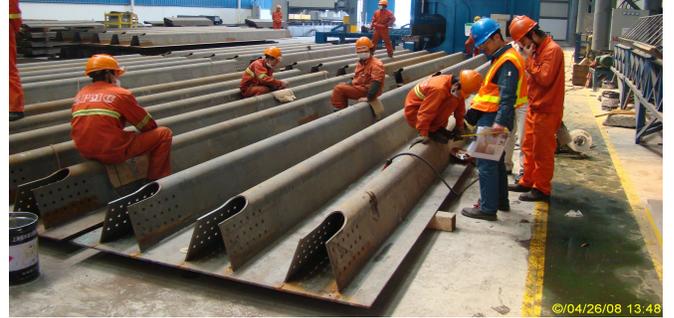
Deck Panel DP013-001 being prepared for weld repair of visual imperfections in Bay 3 of Tower Shop
