DEPARTMENT OF TRANSPORTATION

Quality Assurance and Source Inspection

Contract #: 04-0120F4Cty: SF/ALA Rte: 80 PM: 13.2/13.9File #: 69.28**WELDING INSPECTION REPORT****Resident Engineer:** Pursell, Gary**Address:** 333 Burma Road**City:** Oakland, CA 94607**Report No:** WIR-002205**Date Inspected:** 15-Apr-2008**Project Name:** SAS Superstructure**OSM Arrival Time:** 1400**Prime Contractor:** American Bridge/Fluor Enterprises, a JV**OSM Departure Time:** 2330**Contractor:** Zhenhua Port Machinery Company, Ltd (ZPMC), Changxing Island **Location:** Shanghai, China**CWI Name:** Shu Zhong Hai/An Qing Xing**CWI Present:** Yes No**Inspected CWI report:** Yes No N/A**Rod Oven in Use:** Yes No N/A**Electrode to specification:** Yes No N/A**Weld Procedures Followed:** Yes No N/A**Qualified Welders:** Yes No N/A**Verified Joint Fit-up:** Yes No N/A**Approved Drawings:** Yes No N/A**Approved WPS:** Yes No N/A**Delayed / Cancelled:** Yes No N/A**Bridge No:** 34-0006**Component:** OBG/Tower**Summary of Items Observed:**

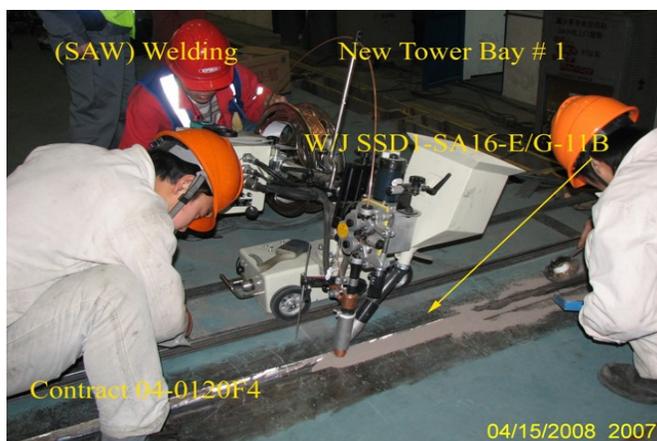
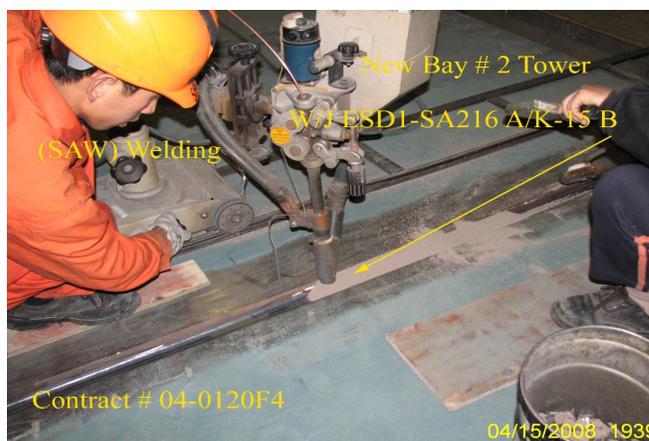
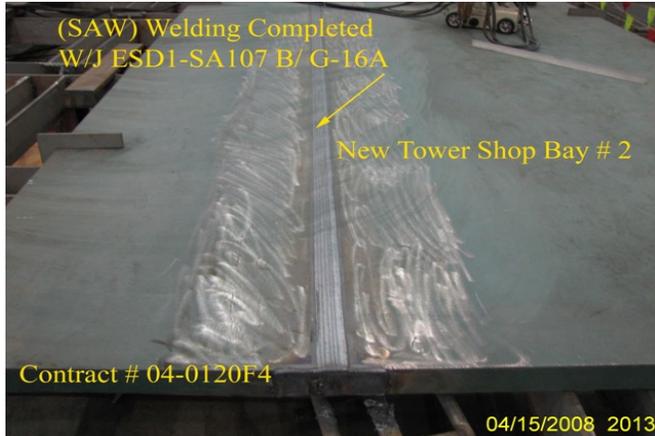
The QA Inspector observed welding operator Xin Yong Liu, ID 048882 performing the Submerged Arc Welding Process (SAW) at the front of Bay # 2 utilizing WPS) WPS-B-T-2221-B-U3L-S-1 in the 1G (Groove) position to weld fill passes for a complete joint penetration (CJP) weld joint for tower skin plate Weld Joint designated as ESD-SA216 A/K-15B, and welding operator Xue Yian, ID 040634 at the back of bay #2 utilizing WPS) WPS-B-T-2221-B-U3L-S-1 in the 1G (Groove) position to weld fill passes for a complete joint penetration (CJP) weld joint for a tower skin plate Weld Joint which was designated as ESD-SA170 B/G-16A in the process of welding

The QA Inspector observed welding operator Xu Xiusui ID 040489 performing the Submerged Arc Welding Process (SAW) utilizing WPS) WPS-B-T-2221-B-U3L-S-1 in the 1G (Groove) position to weld fill passes for a complete joint penetration (CJP) weld joint for tower skin plate Weld Joint designated as SSD1-SA16-E/G-11B.

The work being performed was in progress and generally appeared to conform to contract specifications. For more detail see photographs shown below:
