DEPARTMENT OF TRANSPORTATION

Contract #: 04-0120F4Cty: SF/ALA Rte: 80 PM: 13.2/13.9File #: 69.28**WELDING INSPECTION REPORT****Resident Engineer:** Pursell, Gary**Address:** 333 Burma Road**City:** Oakland, CA 94607**Report No:** WIR-002209**Date Inspected:** 11-Apr-2008**Project Name:** SAS Superstructure**OSM Arrival Time:** 700**Prime Contractor:** American Bridge/Fluor Enterprises, a JV**OSM Departure Time:** 1630**Contractor:** Zhenhua Port Machinery Company, Ltd (ZPMC), Changxing Island **Location:** Shanghai, China**CWI Name:** Chih Chen**CWI Present:** Yes No**Inspected CWI report:** Yes No N/A**Rod Oven in Use:** Yes No N/A**Electrode to specification:** Yes No N/A**Weld Procedures Followed:** Yes No N/A**Qualified Welders:** Yes No N/A**Verified Joint Fit-up:** Yes No N/A**Approved Drawings:** Yes No N/A**Approved WPS:** Yes No N/A**Delayed / Cancelled:** Yes No N/A**Bridge No:** 34-0006**Component:** Orthotropic Box Girder (OBG)**Summary of Items Observed:**

WELDING INSPECTION REPORT

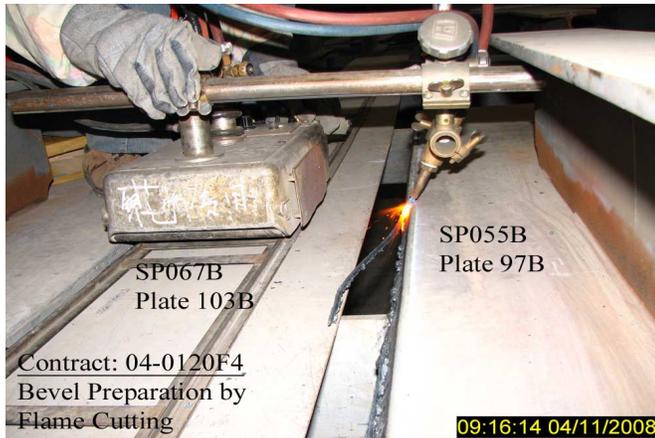
Also in the same general area the QA Inspector observed ZPMC personnel Shi Guijv performing flame cutting operations for bevel preparation on SP055B and SP067B (see digital photo below). The plate numbers are 97B and 103B. The QA Inspector used a bridge cam gauge to perform a random verification of bevel and determined that the work appeared to comply with the contract specifications. The QA Inspector also observed bevel preparations in progress on SP74B and SP62B, plate 107C and 100D.

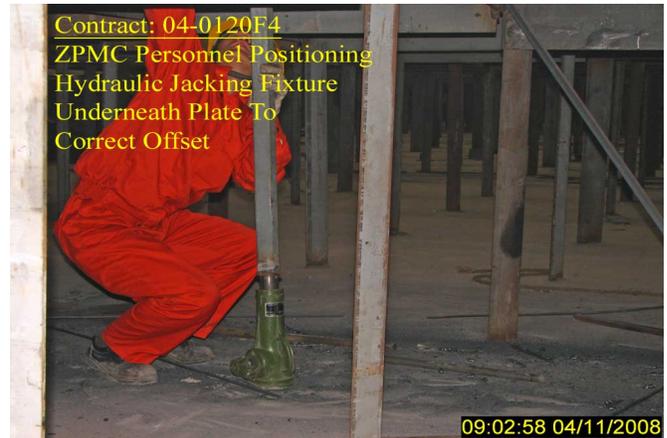
During a random observation the QA Inspector observed ZPMC welding personnel Gu Xue Ying (ID D45218) utilizing the Shielded Metal Arc Welding (SMAW) process in the flat position to place tack welds in the single Vee weld joint between bottom plates designated as BP13A and BP14A (see digital photo below). The segment designation at this location is SEG017A-003. The QA Inspector observed that the welder was using TL-508, E7018, 3.2mm diameter electrode to complete the tack welds. The QA Inspector also noted WPS-B-P-2211-B-U2, Revision 1 as the welding procedure in use for this location. As the tack welding progressed, it was discovered by ZPMC QC Inspector Chih Chen that there was an offset between the plates of about 4mm. The QA Inspector observed no tack welds in this area at this time and observed ZPMC installing a hydraulic jacking fixture underneath the work to correct the offset. During a later observation, the QA Inspector used a straight edge ruler and verified the offset was corrected. The work in progress and the fit-up at this location appeared to comply with the contract specifications and the noted WPS.
