DEPARTMENT OF TRANSPORTATION

Quality Assurance and Source Inspection

Contract #: 04-0120F4Cty: SF/ALA Rte: 80 PM: 13.2/13.9File #: 69.28**WELDING INSPECTION REPORT****Resident Engineer:** Pursell, Gary**Address:** 333 Burma Road**City:** Oakland, CA 94607**Report No:** WIR-002246**Date Inspected:** 07-May-2008**Project Name:** SAS Superstructure**OSM Arrival Time:** 2300**Prime Contractor:** American Bridge/Fluor Enterprises, a JV**OSM Departure Time:** 730**Contractor:** Zhenhua Port Machinery Company, Ltd (ZPMC), Changxing Island **Location:** Shanghai China**CWI Name:** Chen Xi**CWI Present:** Yes No**Inspected CWI report:** Yes No N/A**Rod Oven in Use:** Yes No N/A**Electrode to specification:** Yes No N/A**Weld Procedures Followed:** Yes No N/A**Qualified Welders:** Yes No N/A**Verified Joint Fit-up:** Yes No N/A**Approved Drawings:** Yes No N/A**Approved WPS:** Yes No N/A**Delayed / Cancelled:** Yes No N/A**Bridge No:** 34-0006**Component:** Deck U-Rib Panels**Summary of Items Observed:**

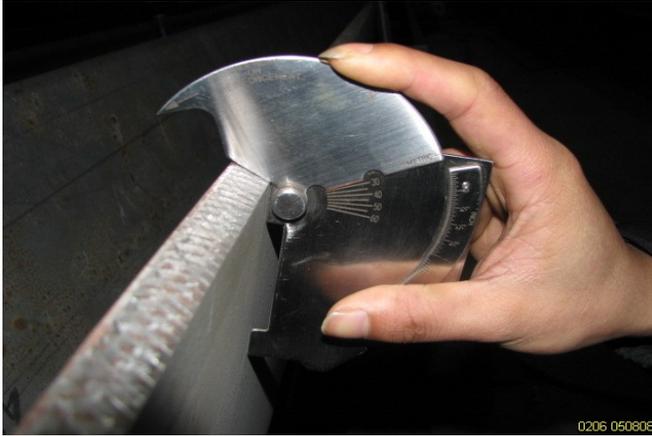
Item	Description	WBS	Dwg No.	Status
1	Picture 1 / Weld joint 004 on DP356-001 CWI Chen XI checking bevel angle prior to fit-up on U-Rib weld joint to deck panel.	B-T-2342-U2		In-work
2	Picture 2 / DP410-001 Fit-up and FCAW CJP Welding of U-Rib splice	B-T-2233-B-U2-F		In-work
3	Picture 3 / DP356-001 CWI Chen Xi monitoring GMAW welding current parameters.	B-T-2242-U2		In-work
4	Picture 4 / DP410-001 CWI Chen Xi inspecting bevel angle prior to fit-up on weld 190.	B-T-2233- B-U2-F		In-work
