Contract #: 04-0120F4Cty: SF/ALA Rte: 80 PM: 13.2/13.9File #: 69.28**WELDING INSPECTION REPORT****Resident Engineer:** Pursell, Gary**Address:** 333 Burma Road**City:** Oakland, CA 94607**Report No:** WIR-002254**Date Inspected:** 05-May-2008**Project Name:** SAS Superstructure**OSM Arrival Time:** 2300**Prime Contractor:** American Bridge/Fluor Enterprises, a JV**OSM Departure Time:** 730**Contractor:** Zhenhua Port Machinery Company, Ltd (ZPMC), Changxing Island **Location:** Shanghai, China

Caltrans Quality Assurance (QA) Inspector, Mike Hasler was present to observe the fitup, welding and related activities associated with the fabricating of Caltrans Mock-up, 77M, 89M, 114M, Orthotropic Box Girder (OBG) and Tower, for the San Francisco Oakland Bay Self Anchored Suspension Bridge, at Zhenhua Port Machinery Company (ZPMC) facility on Changxing Island.

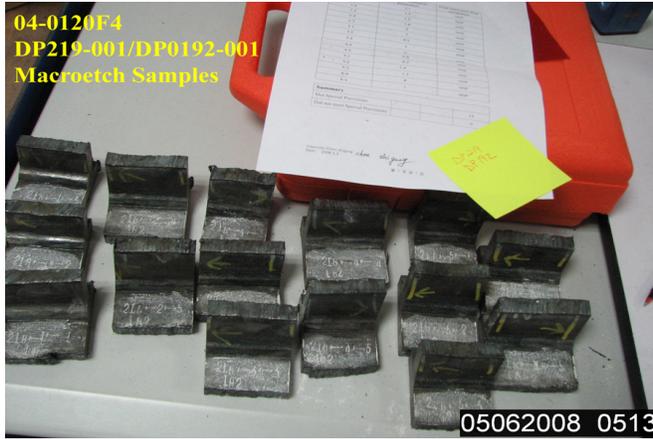
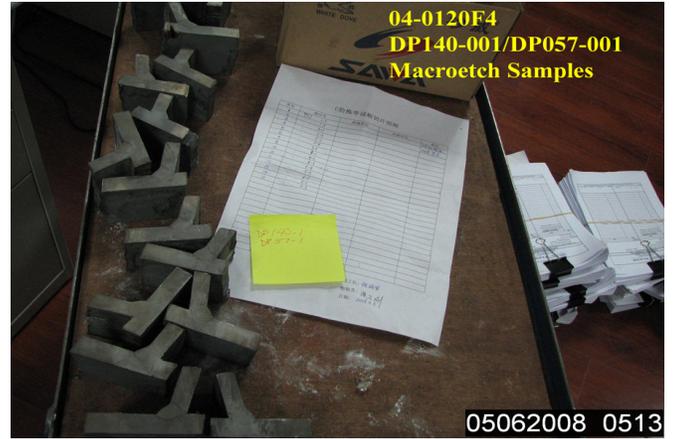
Production Monitoring Tests Macro Etches: Caltrans QA Inspector performed a visual inspection of the production monitoring tests (PMT) macro etch samples presented by ZPMC inspector, Mr. Zhang Jiadi and are identified as DP219-001/DP192-001 and DP140-001/DP057-001. The PMT was welded on 05-04-08. All samples appeared to contain penetration greater than 80 percent. However, macro etch samples for DP140-001/DP057-001 was returned to ZPMC for noncompliant macro etch. The samples are to be re-etched and presented to Caltrans QA for visual inspection. All data from the review was recorded in Caltrans tracking log. See Caltrans tracking log, dated 05-05-08 for additional information. The following digital picture illustrated macro etch samples.
