**DEPARTMENT OF TRANSPORTATION**

Contract #: 04-0120F4Cty: SF/ALA Rte: 80 PM: 13.2/13.9File #: 69.28**WELDING INSPECTION REPORT****Resident Engineer:** Pursell, Gary**Address:** 333 Burma Road**City:** Oakland, CA 94607**Report No:** WIR-002257**Date Inspected:** 28-Apr-2008**Project Name:** SAS Superstructure**OSM Arrival Time:** 2300**Prime Contractor:** American Bridge/Fluor Enterprises, a JV**OSM Departure Time:** 730**Contractor:** Zhenhua Port Machinery Company, Ltd (ZPMC), Changxing Island **Location:** Shanghai, China**CWI Name:****CWI Present:**

**Bridge No:** 34-0006**Component:** Tower & OBG**Summary of Items Observed:**

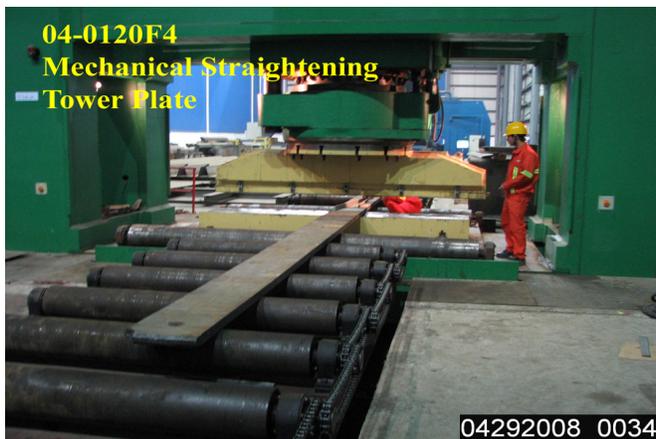
| Item | Description | WBS | Dwg No. | Status |
|---|---|---|---|---|
| 2 | Tower Skin Plate<br>New Tower Shop Bay 3: Caltrans QA observed ZPMC mechanical straightening of the tower skin plate, identified as P527. The plate is being straightened at the 3000 ton press. Caltrans QA observed ZPMC QC inspector, Mr. Shi Yu monitoring the straightening of the tower (longitudinal) stiffener plate. The following digital picture illustrates mechanical straightening. | NA | NA | Mechanical Straightening |

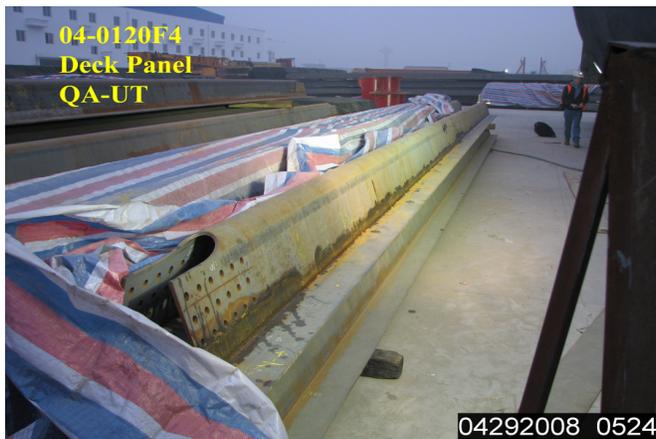
- 3 Deck Panel NA NA QA-UT  
New OBG Shop, Outside Storage Yard: Caltrans QA Inspector performed an Ultrasonic Test (UT) inspection of the partial joint penetration (PJP) weld joining the closed u-rib to the deck panel. The deck panel assembly is identified as DP041-001 and weld 006. Caltrans QA Inspectors, Mr. Mike Hasler UT tested, Y-0 to 7480mm mark and Mr. Paul Dawson tested Y-7480 to 14960mm, UT weld coverage, 100 percent. Caltrans QA Inspectors recorded the results of the inspection and generated an ultrasonic test report. See Caltrans Ultrasonic Testing Report (TL-6027 Modified), dated April, 28, 2008 for additional information. The following digital picture illustrates QA-UT inspected deck panel.

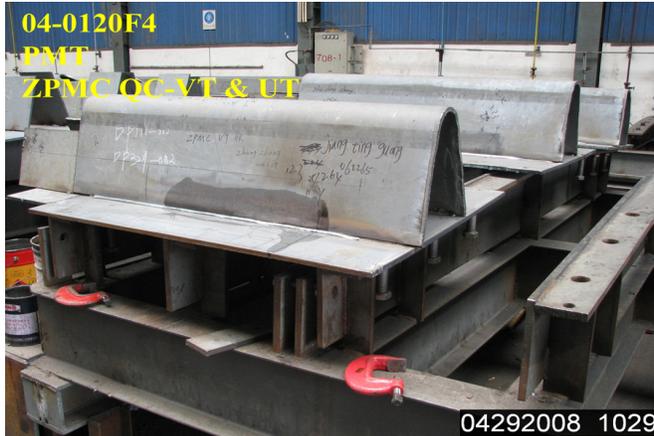
- 4 PMT NA NA ZPMC VT & UT  
OBG Bay 1: Caltrans QA was notified by ZPMC QC that ZPMC would be performing ultrasonic testing of the production monitoring test (PMT), for closed rib assemblies DP111-002 and DP329-002. Caltrans QA witness ZPMC perform visual and ultrasonic inspection of the PMT. The ZPMC QC inspector performing the UT is identified as Ms. E Shuiqin. The following digital picture illustrates QC inspected PMT.
