Contract #: 04-0120F4Cty: SF/ALA Rte: 80 PM: 13.2/13.9File #: 69.28**WELDING INSPECTION REPORT****Resident Engineer:** Pursell, Gary**Address:** 333 Burma Road**City:** Oakland, CA 94607**Report No:** WIR-002258**Date Inspected:** 27-Apr-2008**Project Name:** SAS Superstructure**OSM Arrival Time:** 2300**Prime Contractor:** American Bridge/Fluor Enterprises, a JV**OSM Departure Time:** 730**Contractor:** Zhenhua Port Machinery Company, Ltd (ZPMC), Changxing Island **Location:** Shanghai, China**CWI Name:** Li Yan hue**CWI Present:** Yes No**Inspected CWI report:** Yes No N/A**Rod Oven in Use:** Yes No N/A**Electrode to specification:** Yes No N/A**Weld Procedures Followed:** Yes No N/A**Qualified Welders:** Yes No N/A**Verified Joint Fit-up:** Yes No N/A**Approved Drawings:** Yes No N/A**Approved WPS:** Yes No N/A**Delayed / Cancelled:** Yes No N/A**Bridge No:** 34-0006**Component:** Tower & OBG**Summary of Items Observed:**

Caltrans Quality Assurance (QA) Inspector, Mike Hasler was present to observe the fitup, welding and related activities associated with the fabricating of Caltrans Mock-up, 77M, 89M, 114M, Orthotropic Box Girders (OBG) and Tower, for the San Francisco Oakland

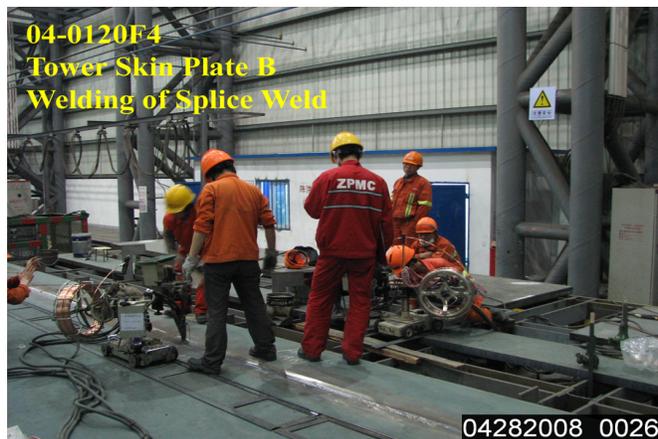
New Tower Shop Bay 2: Caltrans QA Inspector observed ZPMC performing submerged arc welding (SAW), tower skin plate B, SA49 (E) joining P1276 (E), fill pass weld. The weld is identified as ESD1-SA49 C/D- 4, partial joint penetration (PJP) & ESD1-SA233 E/F- 25A, complete joint penetration (CJP). The welder operator is identified as Ms. Shen Mei, welder stamp 041716, utilizing welding procedures WPS-B-T-2221-B-U3c-S (CJP) and WPS-B-T-2321-B-P3-S (PJP). Caltrans QA measured current welding parameters at approximately 660 amps, 33.0 volts and 620mm/min (millimeters per minute) travel speed. Caltrans QA verified preheat and interpass temperatures during the welding of ASTM 709M, Grade 345F2 type materials, 45mm joining 65mm thicknesses. The preheat temperature prior to the start of welding measures more than 110 degrees Celsius but less than 230 degrees Celsius during maximum interpass temperature verification. Caltrans QA observed ZPMC QC/CWI inspector, Mr. Xu Le Feng monitoring the activities at the work station. The following digital picture illustrates welding in progress.

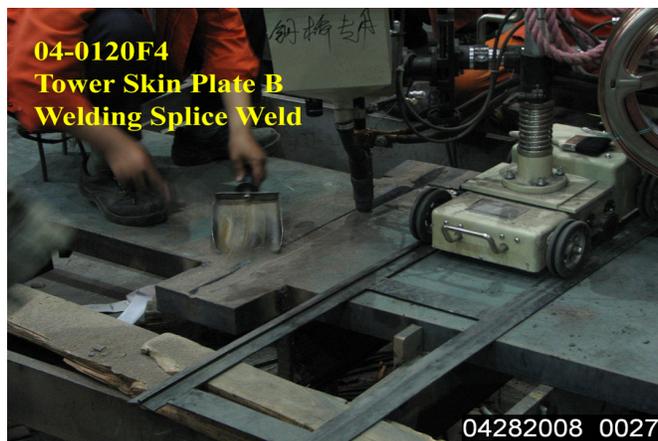
- 2 Tower Skin Plate NA NA Welding
- New Tower Shop Bay 2: Caltrans QA Inspector observed ZPMC performing submerged arc welding (SAW), tower skin plate B, P1280 (E) joining P1277 (E), fill pass weld. The weld is identified as ESD1-SA233 A/F- 22A, complete joint penetration (CJP). The welder operator is identified as Mr. Sun Bing Fa, welder stamp 062046, utilizing welding procedures WPS-B-T-2221-B-U3c-S (CJP). Caltrans QA measured current welding parameters at approximately 655 amps, 33.0 volts and 625mm/min (millimeters per minute) travel speed. Caltrans QA verified preheat and interpass temperatures during the welding of ASTM 709M, Grade 345F2 type materials, 65mm joining 65mm thicknesses. The preheat temperature prior to the start of welding measures more than 110 degrees Celsius but less than 230 degrees Celsius during maximum interpass temperature verification. Caltrans QA observed ZPMC QC/CWI inspector, Mr. Xu Le Feng monitoring the activities at the work station. The following digital picture illustrates welding in progress.

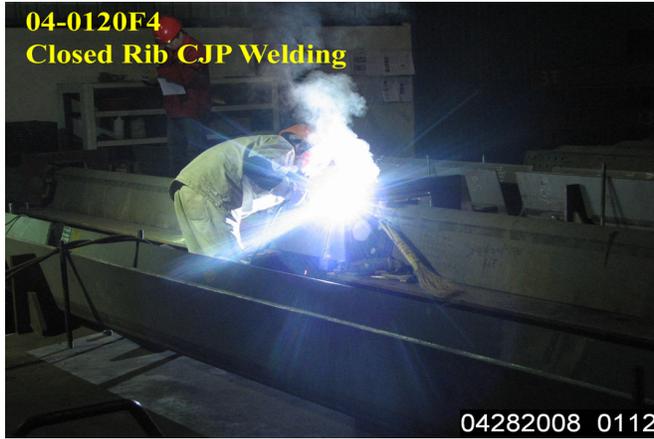
- 3 Deck Panel NA NA Welding
- OBG Bay 1: Caltrans QA observed ZPMC shop workers performing fitup and tack welding, closed u-ribs to deck plate, assembly identified as DP111-002. The tack welders were identified as Mr. Shen Qizhen, welder stamp #059401 and Mr. Hao Long, welder stamp #059446, utilizing welding procedure WPS-B-T-2342-U2 (rib), revision 0. Caltrans QA also observed the welding the of closed u-rib complete joint penetration (CJP) splice weld, subassembly u-rib identified as DP464-001-190. The welder is identified as Mr. Song Yin Shu, welder stamp #059421, utilizing welding procedure WPS-B-T-2233-B-U2-F, revision 1. Caltrans QA observed ZPMC QC/CWI inspector, Mr. Li Yan hua monitoring the welding activities at the workstations. The following digital picture illustrates the welding closed rib complete joint penetration splice weld.
