Quality Assurance and Source Inspection

Contract #: 04-0120F4Cty: SF/ALA Rte: 80 PM: 13.2/13.9File #: 69.28**WELDING INSPECTION REPORT****Resident Engineer:** Pursell, Gary**Address:** 333 Burma Road**City:** Oakland, CA 94607**Report No:** WIR-002457**Date Inspected:** 16-Apr-2008**Project Name:** SAS Superstructure**OSM Arrival Time:** 1400**Prime Contractor:** American Bridge/Fluor Enterprises, a JV**OSM Departure Time:** 2330**Contractor:** Zhenhua Port Machinery Company, Ltd (ZPMC), Changxing Island **Location:** Shanghai, China**CWI Name:** Hu Wei Qing/Shi Zhi**CWI Present:** Yes No**Inspected CWI report:** Yes No N/A**Rod Oven in Use:** Yes No N/A**Electrode to specification:** Yes No N/A**Weld Procedures Followed:** Yes No N/A**Qualified Welders:** Yes No N/A**Verified Joint Fit-up:** Yes No N/A**Approved Drawings:** Yes No N/A**Approved WPS:** Yes No N/A**Delayed / Cancelled:** Yes No N/A**Bridge No:** 34-0006**Component:** OBG/Tower**Summary of Items Observed:**

WELDING INSPECTION REPORT

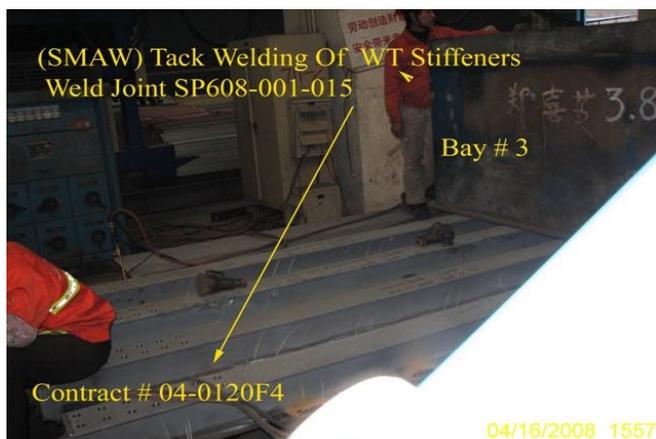
The QA Inspector observed ZPMC qualified Welder The QA Inspector observed ZPMC qualified Welder Zhang Feng ID 049769 utilizing the Shielded Metal Arc Welding (SMAW) Process with ZPMC Weld Procedure Specification (WPS)-B-P-2112-FCM to tack weld various stiffener to plate material for side plates. The markings on the plate material identified indicated the plate was Seismic Performance Critical Member (SPCM) plate material.

The electrode filler metal used during the welding was verified as THJ506FE-1, and the weld joint appeared to be SP755-001-011 and SP755-001-012.

During the welding the QA Inspector verified the welding machine amperes utilizing a Fluke meter which registered 195 amperes.

The QA Inspector observed that during the shift ZPMC CWI, Wu Ming Kai and various ZPMC CAWI Inspectors were monitoring the electrical parameters, travel speed and temperatures at several welding stations in Bay # 3. The work being performed was in progress generally appeared to conform to contract specifications.
