Contract #: 04-0120F4Cty: SF/ALA Rte: 80 PM: 13.2/13.9File #: 69.28**WELDING INSPECTION REPORT****Resident Engineer:** Pursell, Gary**Address:** 333 Burma Road**City:** Oakland, CA 94607**Report No:** WIR-002481**Date Inspected:** 18-May-2008**Project Name:** SAS Superstructure**OSM Arrival Time:** 1800**Prime Contractor:** American Bridge/Fluor Enterprises, a JV**OSM Departure Time:** 730**Contractor:** Zhenhua Port Machinery Company, Ltd (ZPMC), Changxing Island **Location:** Shanghai, China**CWI Name:** Li Yan hua**CWI Present:** Yes No**Inspected CWI report:** Yes No N/A**Rod Oven in Use:** Yes No N/A**Electrode to specification:** Yes No N/A**Weld Procedures Followed:** Yes No N/A**Qualified Welders:** Yes No N/A**Verified Joint Fit-up:** Yes No N/A**Approved Drawings:** Yes No N/A**Approved WPS:** Yes No N/A**Delayed / Cancelled:** Yes No N/A**Bridge No:** 34-0006**Component:** OBG**Summary of Items Observed:**

Caltrans Quality Assurance (QA) Inspector, Mike Hasler was present to observe the fitup, welding and related activities associated with the fabricating of Caltrans Mock-up, 77M, 89M, 114M, Orthotropic Box Girder (OBG) and Tower, for the San Francisco Oakland Bay Self

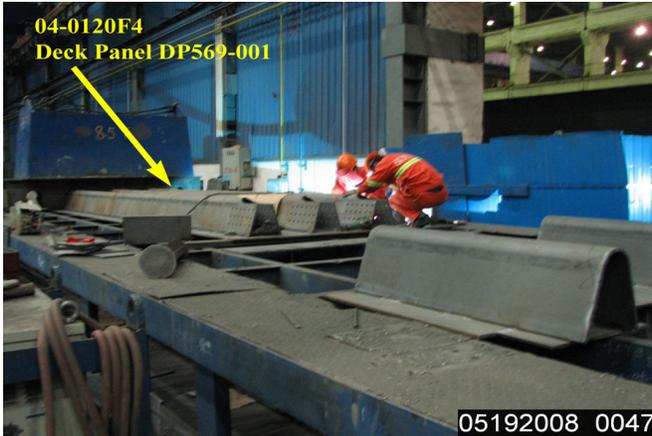
OBG Bay 1: Caltrans QA observed ZPMC shop workers performing fitup and tack welding, closed u-ribs to deck plate, assembly identified as DP569-001. The tack welder is identified as Mr. Li Hua bei, welder stamp #059472, utilizing welding procedure WPS-B-T-2342-U2 (rib), revision 0. Caltrans QA observed ZPMC QC/CWI inspector, Mr. Li Yan hua monitoring the welding activities at the workstation. The following digital picture illustrates fitup and tack welding closed rib to deck plate.

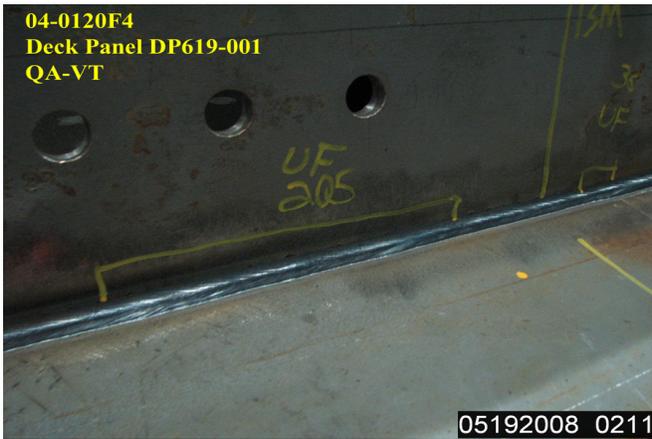
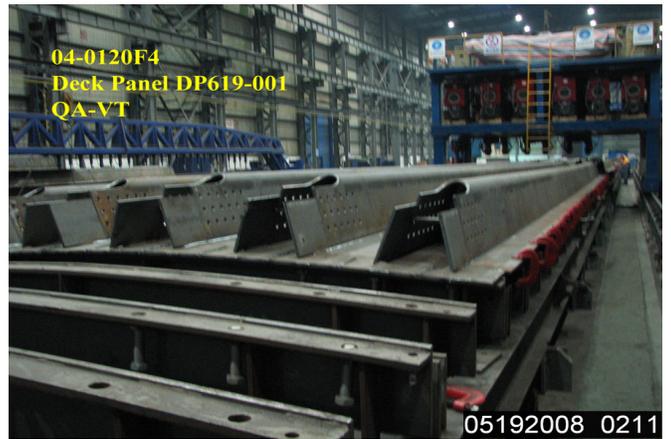
- 2 Deck Panel NA NA QA-VT
- OBG Bay 1- Caltrans QA Inspector performed a Quality Assurance visual weld inspection on Orthotropic Box Girder (OBG) Deck Panel Assembly identified as DP619-001 partial joint penetration (PJP) welds 004 through 009, joining u-ribs to deck plate. QA Inspector observed various defects which include oversize weld, overlap, underfill, undercut and incomplete fusion. The length and the location of each of these areas were recorded on the Caltrans QA Visual Weld Inspection Report for the Orthotropic Box Girder (OBG) and Deck Panel for tracking and distributed to the appropriate personnel for review. The following digital pictures illustrates deck panel DP619-001 and typical markings, identifying weld indications.
