**DEPARTMENT OF TRANSPORTATION**

Contract #: 04-0120F4Cty: SF/ALA Rte: 80 PM: 13.2/13.9File #: 69.28**WELDING INSPECTION REPORT****Resident Engineer:** Pursell, Gary**Address:** 333 Burma Road**City:** Oakland, CA 94607**Report No:** WIR-002492**Date Inspected:** 21-May-2008**Project Name:** SAS Superstructure**OSM Arrival Time:** 2330**Prime Contractor:** American Bridge/Fluor Enterprises, a JV**OSM Departure Time:** 700**Contractor:** Zhenhua Port Machinery Company, Ltd (ZPMC), Changxing Island **Location:** Shanghai China

# WELDING INSPECTION REPORT

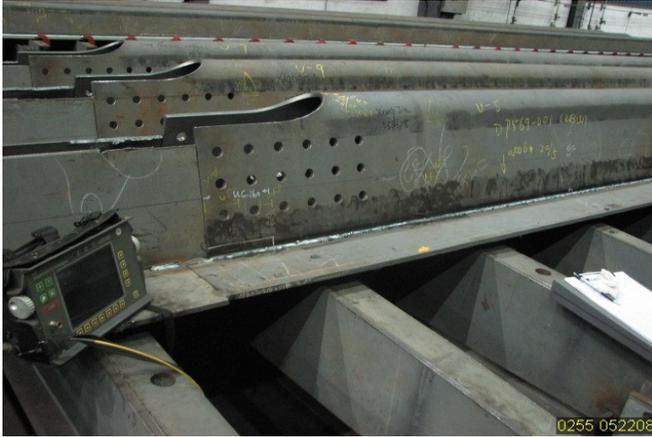
The Caltrans QA Inspector performed ultrasonic inspection of deck plate DP569-001-006 on 15% of partial penetration weld length. Note; ZPMC QC has not performed there UT inspection on this component at the time of this inspection. Items observed by this Inspector appear to comply with project specifications. UT inspection report titled: "04-0120F4\_6027MOD\_B63\_05-21-08\_ZPMC" was submitted to task leader for review.

Item	Description	WBS	Dwg No.	Status
1	Picture 15% QA UT of PJP weld DP569-001 weld 006
