DEPARTMENT OF TRANSPORTATION

Contract #: 04-0120F4Cty: SF/ALA Rte: 80 PM: 13.2/13.9File #: 69.28**WELDING INSPECTION REPORT****Resident Engineer:** Pursell, Gary**Address:** 333 Burma Road**City:** Oakland, CA 94607**Report No:** WIR-002535**Date Inspected:** 21-May-2008**Project Name:** SAS Superstructure**OSM Arrival Time:** 630**Prime Contractor:** American Bridge/Fluor Enterprises, a JV**OSM Departure Time:** 1530**Contractor:** Zhenhua Port Machinery Company, Ltd (ZPMC), Changxing Island **Location:** Shanghai, China

CWI Name:	Zhang Bao Lei and Ye Yong Jun			CWI Present:	Yes	No	
Inspected CWI report:	Yes	No	N/A	Rod Oven in Use:	Yes	No	N/A
Electrode to specification:	Yes	No	N/A	Weld Procedures Followed:	Yes	No	N/A
Qualified Welders:	Yes	No	N/A	Verified Joint Fit-up:	Yes	No	N/A
Approved Drawings:	Yes	No	N/A	Approved WPS:	Yes	No	N/A
				Delayed / Cancelled:	Yes	No	N/A
Bridge No:	34-0006			Component:	OBG and SAS Tower Fabrication

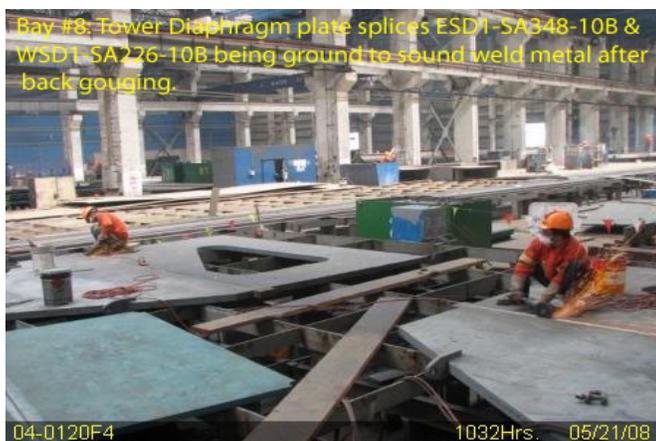
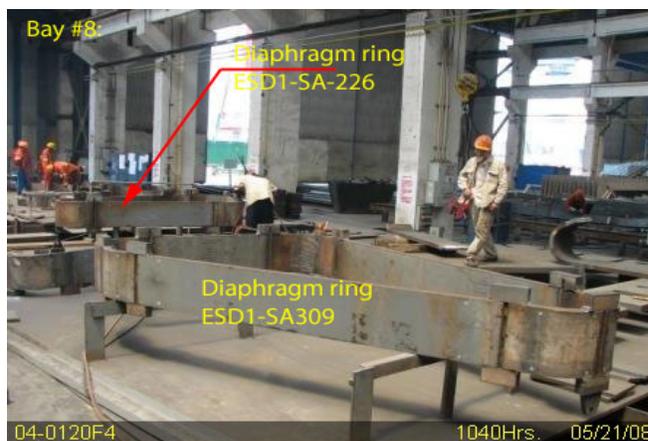
This QA observed bending of various sizes and shapes of heavy metal for diaphragm ring. One plate being bent was P613A(E)-4/23(D) using natural gas of less than 650 degree C thermal heat input with the aid of hydraulic ram and welded jig. The procedure HSR1(T)-1654 is being implemented. Other activities observed that are related to welding include grinding/cleaning of groove after back gouging on diaphragm rings ESD1-SA348-10B and WSD1-SA226-10B and carbon arcing of run off tab on ESD1-SA226.
