**DEPARTMENT OF TRANSPORTATION**

Contract #: 04-0120F4Cty: SF/ALA Rte: 80 PM: 13.2/13.9File #: 69.28**WELDING INSPECTION REPORT****Resident Engineer:** Pursell, Gary**Address:** 333 Burma Road**City:** Oakland, CA 94607**Report No:** WIR-002541**Date Inspected:** 19-May-2008**Project Name:** SAS Superstructure**OSM Arrival Time:** 1400**Prime Contractor:** American Bridge/Fluor Enterprises, a JV**OSM Departure Time:** 2300**Contractor:** Zhenhua Port Machinery Company, Ltd (ZPMC), Changxing Island **Location:** Shanghai, China

**Bridge No:** 34-0006**Component:** OBG side and bottom panels and tower skin p**Summary of Items Observed:**

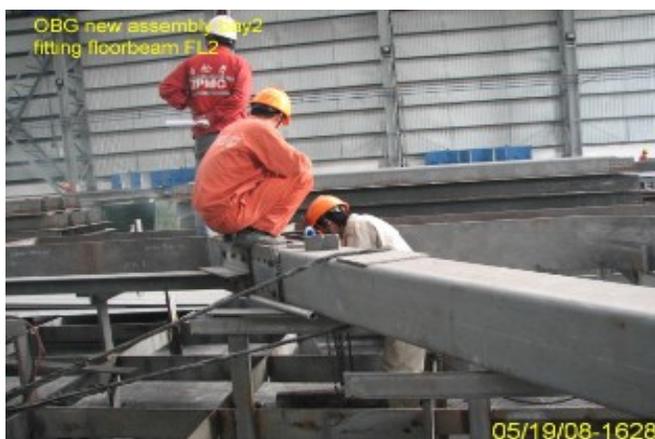
Other general observations in the New Tower bays include ZPMC tack welding tower skin plates, weld bevel preparation, flame straightening, CNC parts cutting and grinding.
