**DEPARTMENT OF TRANSPORTATION**

Contract #: 04-0120F4Cty: SF/ALA Rte: 80 PM: 13.2/13.9File #: 69.28**WELDING INSPECTION REPORT****Resident Engineer:** Pursell, Gary**Address:** 333 Burma Road**City:** Oakland, CA 94607**Report No:** WIR-002545**Date Inspected:** 22-May-2008**Project Name:** SAS Superstructure**OSM Arrival Time:** 1430**Prime Contractor:** American Bridge/Fluor Enterprises, a JV**OSM Departure Time:** 2230**Contractor:** Zhenhua Port Machinery Company, Ltd (ZPMC), Changxing Island **Location:** Shanghai, China

# WELDING INSPECTION REPORT

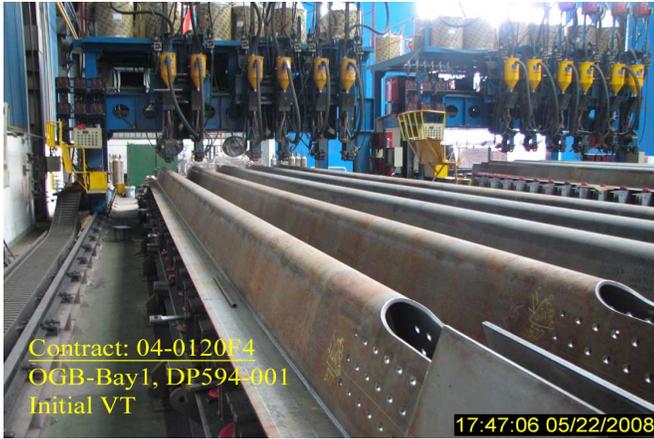
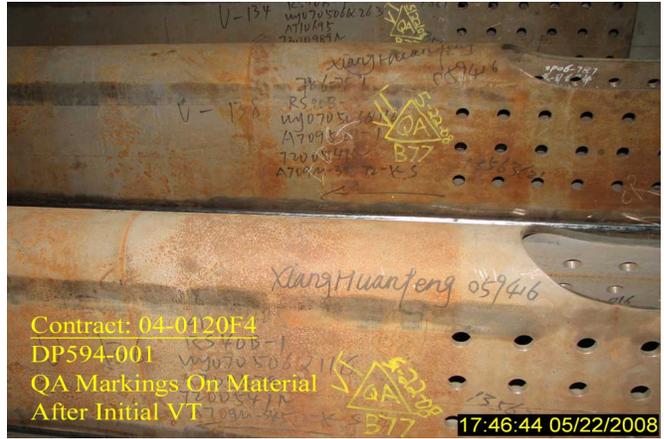
The QA Inspector completed initial visual testing (VT) for the closed rib partial joint penetration (PJP) welds for deck panel designation DP594-001, welds 1 through 10 and recorded Y locations, defect type and defect lengths onto a Caltrans inspection report.

The following digital images below detail DP594-001 as a five rib deck panel and the QA markings that were written at the beginning of each Y location above each weld.
