Contract #: 04-0120F4Cty: SF/ALA Rte: 80 PM: 13.2/13.9File #: 69.28**WELDING INSPECTION REPORT****Resident Engineer:** Pursell, Gary**Address:** 333 Burma Road**City:** Oakland, CA 94607**Report No:** WIR-002632**Date Inspected:** 19-May-2008**Project Name:** SAS Superstructure**OSM Arrival Time:** 2300**Prime Contractor:** American Bridge/Fluor Enterprises, a JV**OSM Departure Time:** 800**Contractor:** Zhenhua Port Machinery Company, Ltd (ZPMC), Changxing Island **Location:** Changxing Island**CWI Name:** Li Yan Hua**CWI Present:** Yes No**Inspected CWI report:** Yes No N/A**Rod Oven in Use:** Yes No N/A**Electrode to specification:** Yes No N/A**Weld Procedures Followed:** Yes No N/A**Qualified Welders:** Yes No N/A**Verified Joint Fit-up:** Yes No N/A**Approved Drawings:** Yes No N/A**Approved WPS:** Yes No N/A**Delayed / Cancelled:** Yes No N/A**Bridge No:** 34-0006**Component:** OBG**Summary of Items Observed:**

Caltrans Quality Assurance (QA) Inspector, Larry Viars was present to perform Visual Testing (VT) of the Orthotropic Box Girder (OBG) components, for the San Francisco Oakland Bay Self Anchored Suspension Bridge, at Zhenhua Port Machinery Company (ZPMC) facility on C

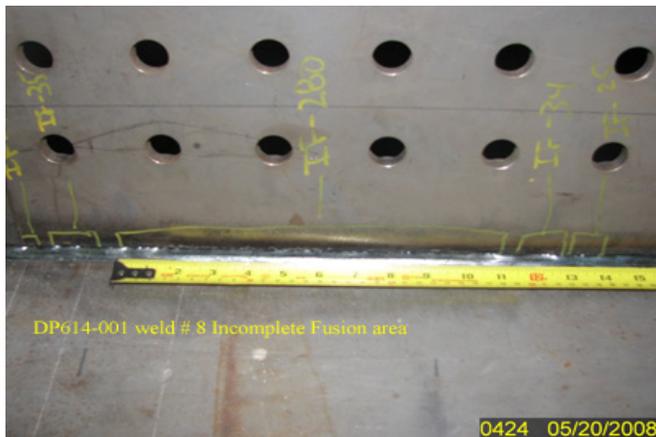
The Caltrans QA Inspector performed visual inspection of OBG 13.567 meter deck panel DP614-001 (welds 006, 007, 008, 009, and 010) U-rib Partial Joint Penetration (PJP) welds. Visual testing of welding was performed in accordance with contract documents. The following discontinuities were found during inspection on the Submerged Arc Welding (SAW) cover pass, incomplete fusion, overlap, undercut, underfill and oversize welds. Welding discontinuities were marked on deck panel with a permanent marker, length and Y location recorded. Visual Inspection results were distributed to the appropriate personnel for review. A summary of discontinuities on inspected U- rib PJP welds are listed below.

DP614-001-006, Incomplete Fusion 4 areas, and Underfill 5 areas

DP614-001-007, Incomplete Fusion 4 areas, and Underfill 10 areas

DP614-001-008, Incomplete Fusion 27 areas, Underfill 1 area, and Undercut 4 areas

DP614-001-009, Underfill 20 areas

DP614-001-010, Incomplete Fusion 7 areas, Underfill 3 areas, Overlap 3 areas
