Contract #: 04-0120F4Cty: SF/ALA Rte: 80 PM: 13.2/13.9File #: 99.28**WELDING INSPECTION REPORT****Resident Engineer:** Pursell, Gary**Address:** 333 Burma Road**City:** Oakland, CA 94607**Report No:** WIR-002677**Date Inspected:** 13-May-2008**Project Name:** SAS Superstructure**OSM Arrival Time:** 830**Prime Contractor:** American Bridge/Fluor Enterprises, a JV**OSM Departure Time:** 1830**Contractor:** Japan Steel Works, Ltd.**Location:** Muroran, Japan

CWI Name:	Tomio Imai and Motoi Hidaka	CWI Present:	Yes	No
Inspected CWI report:	Yes No N/A	Rod Oven in Use:	Yes	No N/A
Electrode to specification:	Yes No N/A	Weld Procedures Followed:	Yes	No N/A
Qualified Welders:	Yes No N/A	Verified Joint Fit-up:	Yes	No N/A
Approved Drawings:	Yes No N/A	Approved WPS:	Yes	No N/A
		Delayed / Cancelled:	Yes	No N/A
Bridge No:	34-0006	Component:	Tower, Jacking and Deviation Saddles

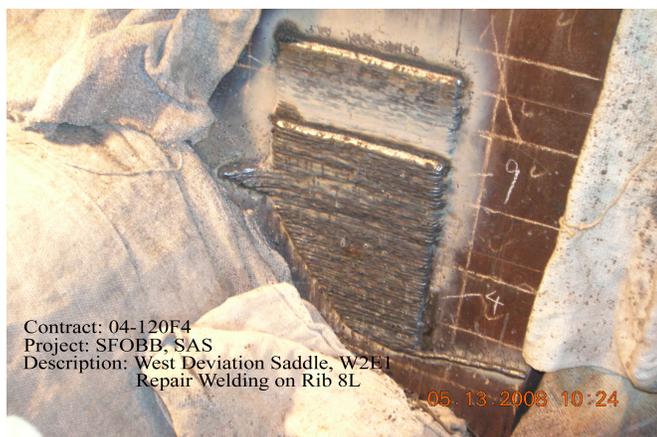
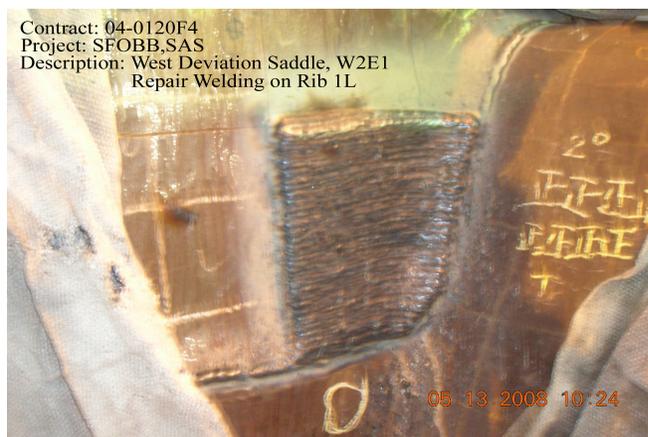
This QA inspector randomly observed the in process Shielded Metal Arc Welding (SMAW) for the repair welding of the ribs on the West Deviation Saddles identified as W2E1. This QA inspector noted that it appeared the approved and latest revised WPS's were posted at the appropriate welding station and that each approved welder was entered in the latest revised Welding Personnel Log issued by Japan Steel Works, Ltd. The welding

parameters, preheat and interpass temperatures were verified as noted by this QA inspector utilizing a Fluke 337 clamp meter for the electrical welding parameters and Tempilstik temperature indicators for preheat and interpass temperatures. The filler metal utilized at the welding stations was also verified. The QC inspectors, Tomio Imai and Motoi-Hidaka appeared to perform the visual examinations and monitoring of the welding per the contract documents. The welding and inspection was not completed during this shift and appeared to be in general compliance with the contract documents.

The following digital photographs illustrate the observations of the activities performed on this date.
