**DEPARTMENT OF TRANSPORTATION**

Contract #: 04-0120F4Cty: SF/ALA Rte: 80 PM: 13.2/13.9File #: 69.28**WELDING INSPECTION REPORT****Resident Engineer:** Pursell, Gary**Address:** 333 Burma Road**City:** Oakland, CA 94607**Report No:** WIR-002715**Date Inspected:** 29-May-2008**Project Name:** SAS Superstructure**OSM Arrival Time:** 1400**Prime Contractor:** American Bridge/Fluor Enterprises, a JV**OSM Departure Time:** 2300**Contractor:** Zhenhua Port Machinery Company, Ltd (ZPMC), Changxing Island **Location:** Shanghai, China**CWI Name:** Chen Chih-Ming / Liu Huaie**CWI Present:** Yes No**Inspected CWI report:** Yes No N/A**Rod Oven in Use:** Yes No N/A**Electrode to specification:** Yes No N/A**Weld Procedures Followed:** Yes No N/A**Qualified Welders:** Yes No N/A**Verified Joint Fit-up:** Yes No N/A**Approved Drawings:** Yes No N/A**Approved WPS:** Yes No N/A**Delayed / Cancelled:** Yes No N/A**Bridge No:** 34-0006**Component:** OBG side and bottom panels and tower skin p**Summary of Items Observed:**

## WELDING INSPECTION REPORT

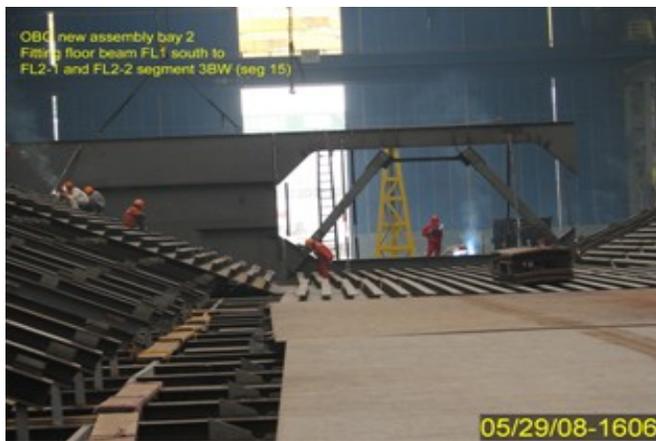
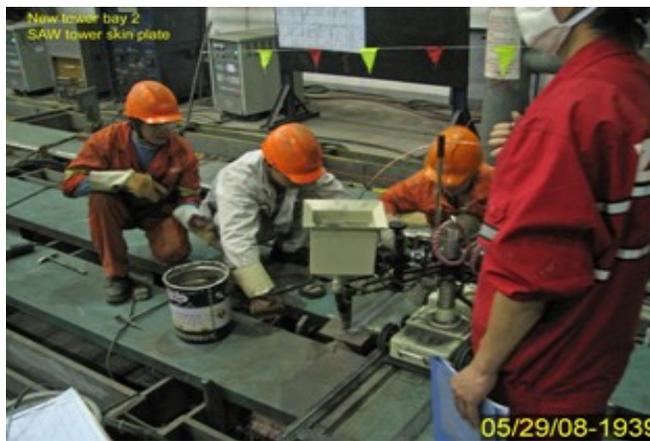
Other general observations in the New Tower bays include weld bevel preparation, flame straightening, CNC parts cutting, hole drilling and grinding.
