DEPARTMENT OF TRANSPORTATION

Quality Assurance and Source Inspection

Contract #: 04-0120F4Cty: SF/ALA Rte: 80 PM: 13.2/13.9File #: 69.28**WELDING INSPECTION REPORT****Resident Engineer:** Pursell, Gary**Address:** 333 Burma Road**City:** Oakland, CA 94607**Report No:** WIR-002728**Date Inspected:** 29-May-2008**Project Name:** SAS Superstructure**OSM Arrival Time:** 2330**Prime Contractor:** American Bridge/Fluor Enterprises, a JV**OSM Departure Time:** 700**Contractor:** Zhenhua Port Machinery Company, Ltd (ZPMC), Changxing Island **Location:** Shanghai China

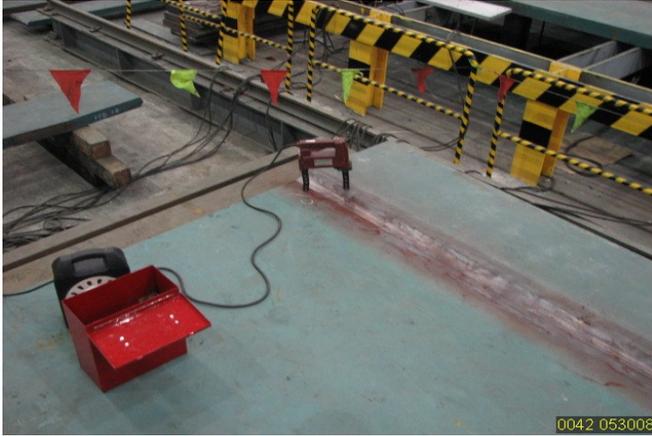
The Caltrans QA Inspector performed Magnetic Particle Testing (MT) verification of the QC MT inspected and accepted welds. QA Inspector's MT verification appears to be acceptable with AWS D1.5-02 section 6.26.2.1 & 6.26.2.3 Reference QA Magnetic Particle Test Report TL-6028 dated 5-29-08 for specific test data.

Item	Description	WBS	Dwg No.	Status
1	Picture at above left MT on skin plate transition weld SSDI SA18 of various welds			
3	Picture at right Measuring weld size on the repaired PJP weld on DP025-001 weld 001.

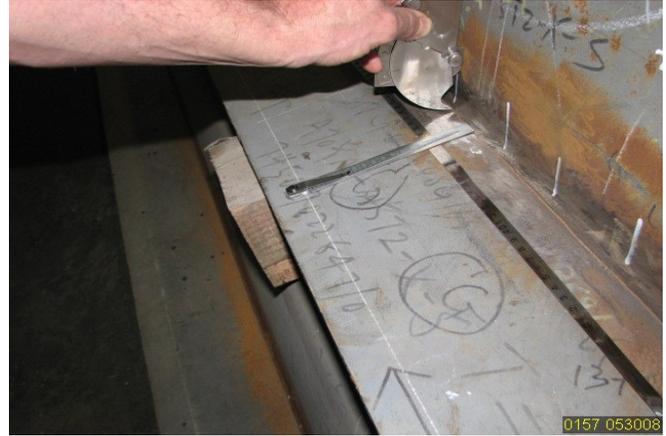
The Caltrans QA Inspector Mr. David Kelsey performed Final Visual Testing (VT) and (MT) on DP025-001; partial penetration repair welds 001 thru 006. This inspector found the ZPMC repairs to be compliant with contract Special Provisions and welding code AWS D1.5 2002. This Inspectors results and repair locations were recorded on the OBG deck panel weld inspection report and turned into the appropriate personnel and filed in the deck panel log book.
