DEPARTMENT OF TRANSPORTATION

Contract #: 04-0120F4Cty: SF/ALA Rte: 80 PM: 13.2/13.9File #: 69.28**WELDING INSPECTION REPORT****Resident Engineer:** Pursell, Gary**Address:** 333 Burma Road**City:** Oakland, CA 94607**Report No:** WIR-002755**Date Inspected:** 30-May-2008**Project Name:** SAS Superstructure**OSM Arrival Time:** 2300**Prime Contractor:** American Bridge/Fluor Enterprises, a JV**OSM Departure Time:** 800**Contractor:** Zhenhua Port Machinery Company, Ltd (ZPMC), Changxing Island **Location:** Changxing Island**CWI Name:** Jiang Jian Fei**CWI Present:** Yes No**Inspected CWI report:** Yes No N/A**Rod Oven in Use:** Yes No N/A**Electrode to specification:** Yes No N/A**Weld Procedures Followed:** Yes No N/A**Qualified Welders:** Yes No N/A**Verified Joint Fit-up:** Yes No N/A**Approved Drawings:** Yes No N/A**Approved WPS:** Yes No N/A**Delayed / Cancelled:** Yes No N/A**Bridge No:** 34-0006**Component:** OBG and Tower**Summary of Items Observed:**

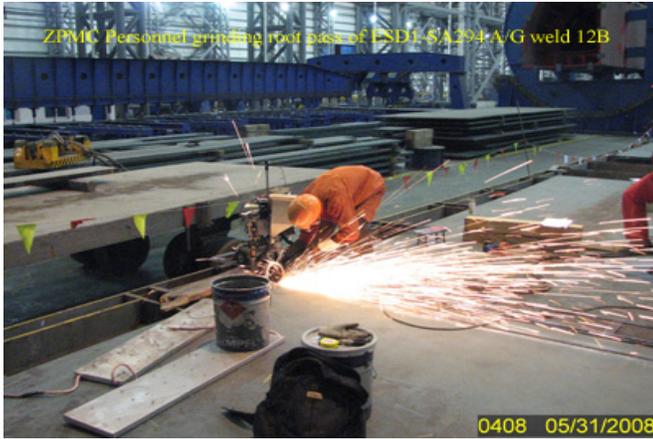
The Caltrans QA Inspector observed ZPMC welder Mr. Gao Guimei performing Submerged Arc Welding (SAW) on Tower Skin plate C weld joint ESD1-SA294 A/G 12B for East Tower in the 1G position. Welding procedure specification WPS-B-T-2221-B-U3C was posted for the above mentioned root pass. The following welding variables were recorded, amperage 632, volts 33.5, travel speed 614, with a heat input of 2.06 kJ/mm. The above mentioned welding appeared to meet the requirements of AWS D1.5 (2002) and applicable contract documents. Please see the attached photo of ZPMC personnel grinding the above mentioned root pass after welding.
