**DEPARTMENT OF TRANSPORTATION**

Contract #: 04-0120F4Cty: SF/ALA Rte: 80 PM: 13.2/13.9File #: 69.28**WELDING INSPECTION REPORT****Resident Engineer:** Pursell, Gary**Address:** 333 Burma Road**City:** Oakland, CA 94607**Report No:** WIR-002791**Date Inspected:** 27-May-2008**Project Name:** SAS Superstructure**OSM Arrival Time:** 1330**Prime Contractor:** American Bridge/Fluor Enterprises, a JV**OSM Departure Time:** 2230**Contractor:** Zhenhua Port Machinery Company, Ltd (ZPMC), Changxing Island **Location:** Shanghai, China

## WELDING INSPECTION REPORT

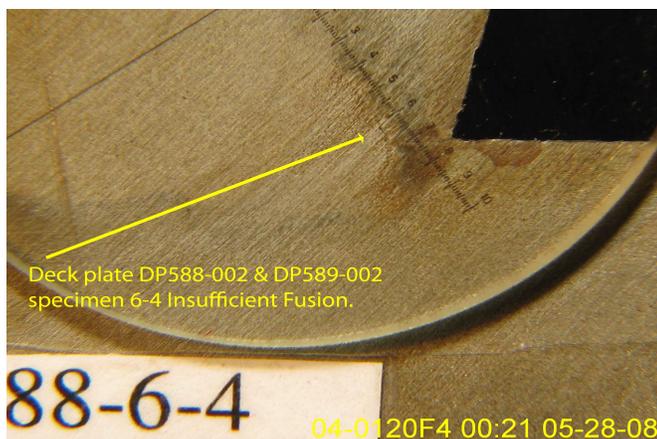
Around 2015 hours ABF QA Representative Mr. Kevin Dye informed the QA Inspector that weld macroetch specimens for deck plates DP-588-002 and DP-589-002 are ready for QA visual inspections. The QA Inspector performed visual and dimensional inspections of fifteen (15) each closed rib production monitoring tests (PMT) macro etch specimens representing deck plates DP-588-002 and DP-589-002 closed rib welds that were welded on May 26, 2008. Note: On May 26, 2008 Deck Plate DP589-002 was welded with one pass of GMAW and no submerged arc welds were completed on this Deck Plate. The macroetch specimens were not presented to the QA Inspector until today. ZPMC QC CWI Inspector Mr. Duan Yabing had previously inspected and accepted these macroetch specimens and American Bridge / Fluor CWI representative Mr. Kevin Dye had visually inspected and indicated that specimen 6-4 is rejected due to incomplete fusion, and the remaining fourteen specimens are acceptable. The QA Inspector agreed with Mr. Dye's evaluations of the weld specimens. The QA Inspector determined all fifteen macroetch specimens contain weld penetration greater than 80 percent. The results of these inspections are documented on an Excel spreadsheet titled "SAS OBG PMT Macroetch Log" and a copy of this

file is posted on the Caltrans “Team China” internal sever computer system. The QA Inspector also made digital photographs of each of the macroetch specimens and copies of these photographs are posted on the Caltrans “Team China” common drive which is accessible to Quality Assurance Task Leaders and Structural Materials Representatives. Below is a digital photograph showing weld specimen 6-4 that was rejected due to incomplete fusion.
