Contract #: 04-0120F4Cty: SF/ALA Rte: 80 PM: 13.2/13.9File #: 69.28**WELDING INSPECTION REPORT****Resident Engineer:** Pursell, Gary**Address:** 333 Burma Road**City:** Oakland, CA 94607**Report No:** WIR-002816**Date Inspected:** 05-Jun-2008**Project Name:** SAS Superstructure**OSM Arrival Time:** 1400**Prime Contractor:** American Bridge/Fluor Enterprises, a JV**OSM Departure Time:** 2300**Contractor:** Zhenhua Port Machinery Company, Ltd (ZPMC), Changxing Island **Location:** Shanghai, China

**Bridge No:** 34-0006**Component:** OBG side and bottom panels and tower skin p**Summary of Items Observed:**

# WELDING INSPECTION REPORT

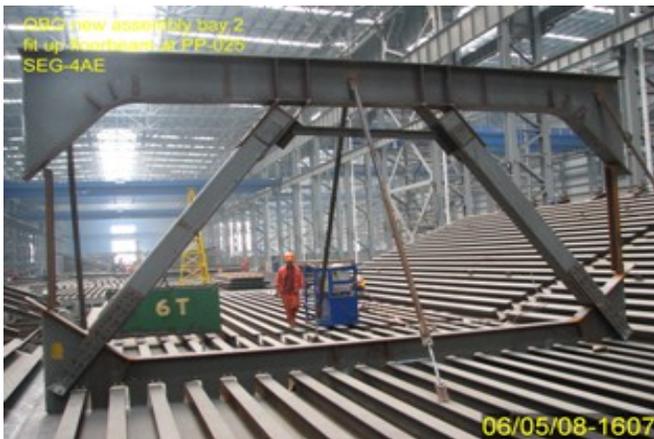
QA performed 10% Ultrasonic Testing (UT) verification on the following tower skin plate joints: SSD1-40A/E-18B, SSD1-17A/G-26B and SSD1-SA179D/E-07A. All welds that were scanned appeared to compliant with AWS D1.5 2002 and the contract documents
