DEPARTMENT OF TRANSPORTATION

Quality Assurance and Source Inspection

Contract #: 04-0120F4Cty: SF/ALA Rte: 80 PM: 13.2/13.9File #: 69.28**WELDING INSPECTION REPORT****Resident Engineer:** Pursell, Gary**Address:** 333 Burma Road**City:** Oakland, CA 94607**Report No:** WIR-002867**Date Inspected:** 10-Jun-2008**Project Name:** SAS Superstructure**OSM Arrival Time:** 1400**Prime Contractor:** American Bridge/Fluor Enterprises, a JV**OSM Departure Time:** 2300**Contractor:** Zhenhua Port Machinery Company, Ltd (ZPMC), Changxing Island **Location:** Shanghai, China**CWI Name:** Chen Chih-Ming / Chen Xi**CWI Present:** Yes No**Inspected CWI report:** Yes No N/A**Rod Oven in Use:** Yes No N/A**Electrode to specification:** Yes No N/A**Weld Procedures Followed:** Yes No N/A**Qualified Welders:** Yes No N/A**Verified Joint Fit-up:** Yes No N/A**Approved Drawings:** Yes No N/A**Approved WPS:** Yes No N/A**Delayed / Cancelled:** Yes No N/A**Bridge No:** 34-0006**Component:** OBG side, bottom and deck panels**Summary of Items Observed:**

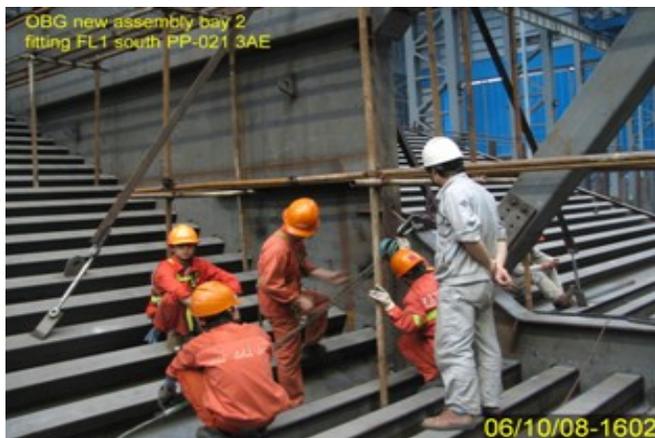
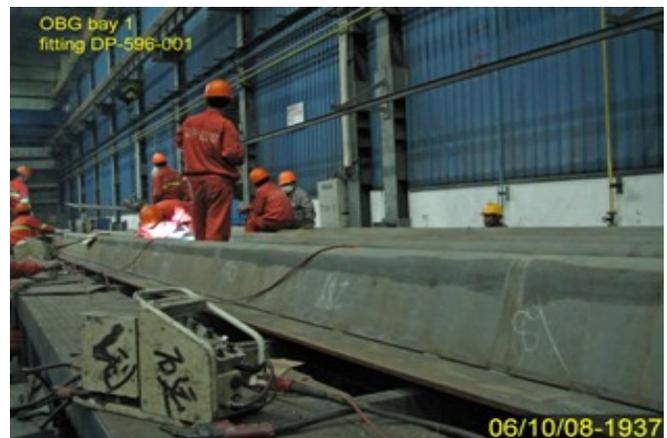
QA observed ZPMC has approximately 45 workers performing various functions relative to the fabrication of the OBG Deck Panels. These functions include; closed rib press forming, hole drilling at ends of U-Ribs using a drill template, PJP bevel preparation, closed rib splice FCAW welding, closed rib diaphragm fit-up and FCAW welding, closed rib to deck plate fit-up and tack welding.
