**DEPARTMENT OF TRANSPORTATION**

Contract #: 04-0120F4Cty: SF/ALA Rte: 80 PM: 13.2/13.9File #: 99.28**WELDING INSPECTION REPORT****Resident Engineer:** Pursell, Gary**Address:** 333 Burma Road**City:** Oakland, CA 94607**Report No:** WIR-002868**Date Inspected:** 27-May-2008**Project Name:** SAS Superstructure**OSM Arrival Time:** 2230**Prime Contractor:** American Bridge/Fluor Enterprises, a JV**OSM Departure Time:** 830**Contractor:** Japan Steel Works, Ltd.**Location:** Muroran, Japan**CWI Name:** Makhmud Ashadi**CWI Present:** Yes No**Inspected CWI report:** Yes No N/A**Rod Oven in Use:** Yes No N/A**Electrode to specification:** Yes No N/A**Weld Procedures Followed:** Yes No N/A**Qualified Welders:** Yes No N/A**Verified Joint Fit-up:** Yes No N/A**Approved Drawings:** Yes No N/A**Approved WPS:** Yes No N/A**Delayed / Cancelled:** Yes No N/A**Bridge No:** 34-0006**Component:** Tower, Jacking and Deviation Saddles**Summary of Items Observed:**

## WELDING INSPECTION REPORT

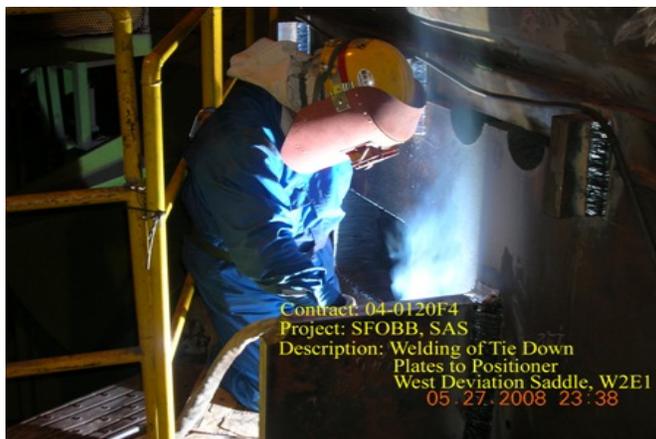
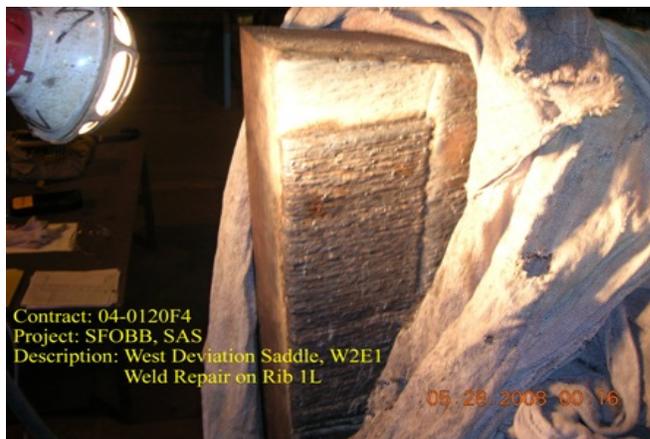
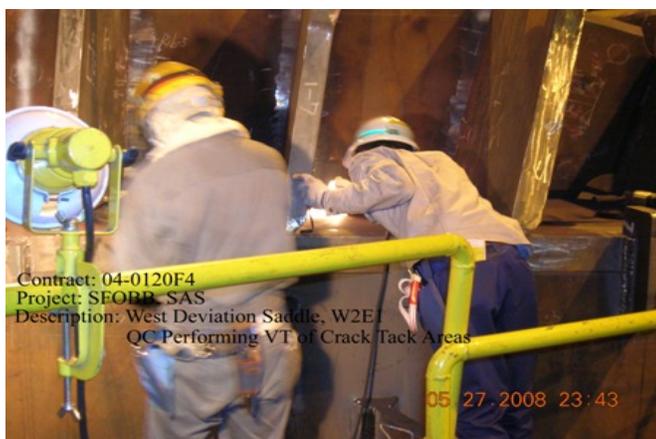
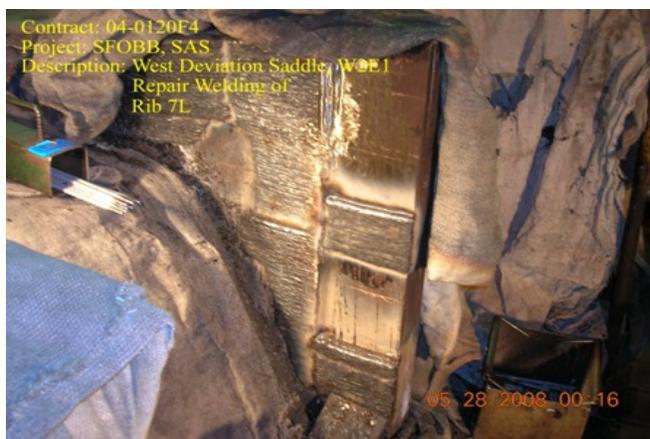
This QA inspector randomly observed the in process Shielded Metal Arc Welding (SMAW) for the repair welding of the ribs on the West Deviation Saddles identified as W2E1. This QA inspector noted that it appeared the approved and latest revised WPS's were posted at the appropriate welding station and that each approved welder was entered in the latest revised Welding Personnel Log issued by Japan Steel Works, Ltd. The welding parameters, preheat and interpass temperatures were verified as noted by this QA inspector utilizing a Fluke 337 clamp meter for the electrical welding parameters and Tempilstik temperature indicators for preheat and interpass temperatures. The filler metal utilized at the welding stations was also verified. The JSW personnel appeared to perform the monitoring and the verification activities of the welding as per the contract documents. The welding and inspection was not completed during this shift and appeared to be in general compliance with the contract documents.

In regards to the removal of the cracked tack welds it appeared that the defective tack welds had been removed and the QC inspector Mahkmud Ashadi appeared to perform the visual inspection as per the contract documents.

The following digital photographs illustrate the observations of the activities performed on this date.
