Contract #: 04-0120F4Cty: SF/ALA Rte: 80 PM: 13.2/13.9File #: 69.28**WELDING INSPECTION REPORT****Resident Engineer:** Pursell, Gary**Address:** 333 Burma Road**City:** Oakland, CA 94607**Report No:** WIR-002879**Date Inspected:** 11-Jun-2008**Project Name:** SAS Superstructure**OSM Arrival Time:** 2300**Prime Contractor:** American Bridge/Fluor Enterprises, a JV**OSM Departure Time:** 700**Contractor:** Zhenhua Port Machinery Company, Ltd (ZPMC), Changxing Island **Location:** Shanghai China**CWI Name:** Chen Xi**CWI Present:** Yes No**Inspected CWI report:** Yes No N/A**Rod Oven in Use:** Yes No N/A**Electrode to specification:** Yes No N/A**Weld Procedures Followed:** Yes No N/A**Qualified Welders:** Yes No N/A**Verified Joint Fit-up:** Yes No N/A**Approved Drawings:** Yes No N/A**Approved WPS:** Yes No N/A**Delayed / Cancelled:** Yes No N/A**Bridge No:** 34-0006**Component:** Deck Panel & PMT**Summary of Items Observed:**

WELDING INSPECTION REPORT

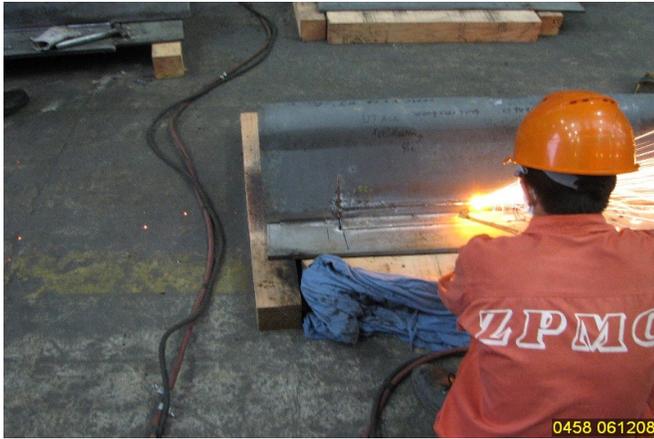
Item	Description	WBS	Dwg No.	Status
1	Picture above left ZPMC thermal cutting out macro samples marked by QA.			
2	Picture above right MT of tack welds on PMT
