Contract #: 04-0120F4Cty: SF/ALA Rte: 80 PM: 13.2/13.9File #: 69.28**WELDING INSPECTION REPORT****Resident Engineer:** Pursell, Gary**Address:** 333 Burma Road**City:** Oakland, CA 94607**Report No:** WIR-002957**Date Inspected:** 10-Jun-2008**Project Name:** SAS Superstructure**OSM Arrival Time:** 1730**Prime Contractor:** American Bridge/Fluor Enterprises, a JV**OSM Departure Time:** 800**Contractor:** Zhenhua Port Machinery Company, Ltd (ZPMC), Changxing Island **Location:** Shanghai, China**CWI Name:** Xu Le Feng**CWI Present:** Yes No**Inspected CWI report:** Yes No N/A**Rod Oven in Use:** Yes No N/A**Electrode to specification:** Yes No N/A**Weld Procedures Followed:** Yes No N/A**Qualified Welders:** Yes No N/A**Verified Joint Fit-up:** Yes No N/A**Approved Drawings:** Yes No N/A**Approved WPS:** Yes No N/A**Delayed / Cancelled:** Yes No N/A**Bridge No:** 34-0006**Component:** Tower & OBG**Summary of Items Observed:**

WELDING INSPECTION REPORT

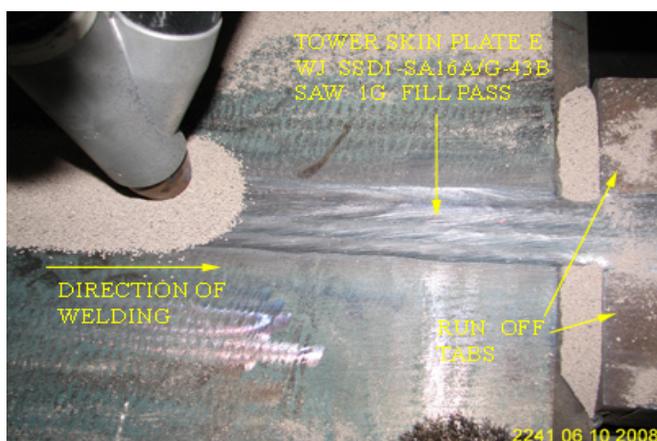
The QA Inspector randomly observed ZPMC QC monitoring weld parameters. The QA Inspector also randomly monitored weld parameters and recorded them as follows: 645 amps, 32.5 volts with a travel speed of 570 millimeters (mm) per minute. The weld parameters appeared to comply with contract requirements. The attached photograph provides additional detail.
