DEPARTMENT OF TRANSPORTATION

Contract #: 04-0120F4Cty: SF/ALA Rte: 80 PM: 13.2/13.9File #: 69.28**WELDING INSPECTION REPORT****Resident Engineer:** Pursell, Gary**Address:** 333 Burma Road**City:** Oakland, CA 94607**Report No:** WIR-002973**Date Inspected:** 12-Jun-2008**Project Name:** SAS Superstructure**OSM Arrival Time:** 700**Prime Contractor:** American Bridge/Fluor Enterprises, a JV**OSM Departure Time:** 1700**Contractor:** Zhenhua Port Machinery Company, Ltd (ZPMC), Changxing Island **Location:** Shanghai, China**CWI Name:** Sun Wei**CWI Present:** Yes No**Inspected CWI report:** Yes No N/A**Rod Oven in Use:** Yes No N/A**Electrode to specification:** Yes No N/A**Weld Procedures Followed:** Yes No N/A**Qualified Welders:** Yes No N/A**Verified Joint Fit-up:** Yes No N/A**Approved Drawings:** Yes No N/A**Approved WPS:** Yes No N/A**Delayed / Cancelled:** Yes No N/A**Bridge No:** 34-0006**Component:** OBG and Tower**Summary of Items Observed:**

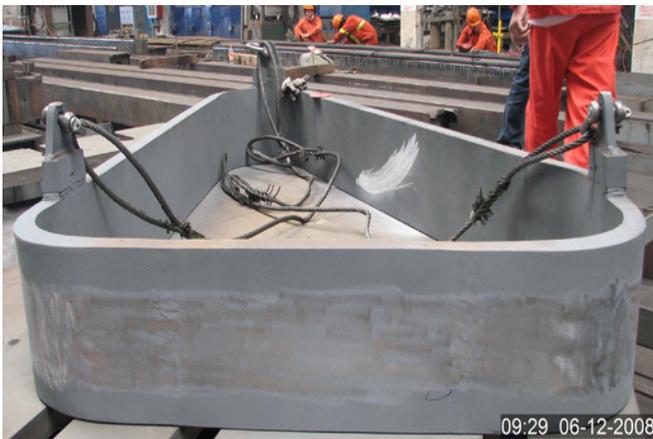
The Quality Assurance inspector observed there are 9 diaphragm flanges in various stages of fabrication from fit-up of the complete joint penetration splices to welding in progress. The Quality Assurance Inspector observed that ZPMC painted a diaphragm flange for the 43M elevation for diaphragm SA27. Below is a digital photograph illustrating the painted part. The centerline of the part has been ground in preparation for welding to the diaphragm plate.
