DEPARTMENT OF TRANSPORTATION

Quality Assurance and Source Inspection

Contract #: 04-0120F4Cty: SF/ALA Rte: 80 PM: 13.2/13.9File #: 69.28**WELDING INSPECTION REPORT****Resident Engineer:** Pursell, Gary**Address:** 333 Burma Road**City:** Oakland, CA 94607**Report No:** WIR-003044**Date Inspected:** 23-Jun-2008**Project Name:** SAS Superstructure**OSM Arrival Time:** 1930**Prime Contractor:** American Bridge/Fluor Enterprises, a JV**OSM Departure Time:** 700**Contractor:** Zhenhua Port Machinery Company, Ltd (ZPMC), Changxing Island **Location:** Shanghai China**CWI Name:** Xu La Fong**CWI Present:** Yes No**Inspected CWI report:** Yes No N/A**Rod Oven in Use:** Yes No N/A**Electrode to specification:** Yes No N/A**Weld Procedures Followed:** Yes No N/A**Qualified Welders:** Yes No N/A**Verified Joint Fit-up:** Yes No N/A**Approved Drawings:** Yes No N/A**Approved WPS:** Yes No N/A**Delayed / Cancelled:** Yes No N/A**Bridge No:** 34-0006**Component:** Tower & OBG components**Summary of Items Observed:**

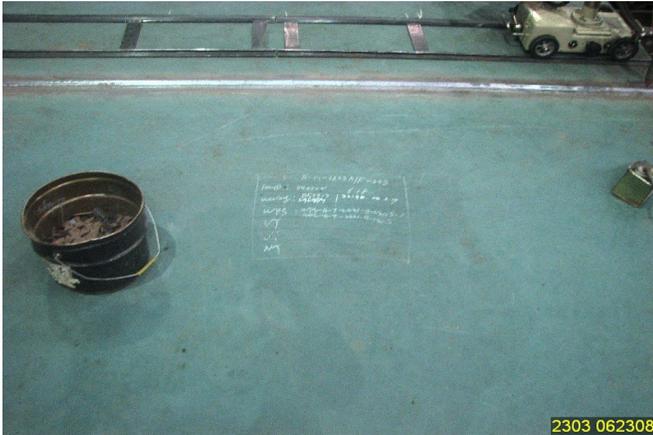
This Inspector performed in-process welding inspection on the submerged arc welding (SAW) process on tower skin plate NSDI SA33 A/F-24A weld splice in Tower shop Bays# 1. This Inspector randomly observed the ZPMC QC/CWI Mr. Xu La Fong (Bay 1) along with three CAWI monitoring welding voltage, pre-heat & interpass temperatures & cleaning, weld pass width, profile/size and travel speed per the approved WPS-B-T-3221-B-U3c-S-1.

The in-process welding, fit-up & joint preparation observed by this Inspector appears to comply with the previously mentioned WPS in this report, the approved drawings, the WQCP, Contract Special Provisions and AWS welding code D1.5 (2002).

Item	Description	WBS	Dwg No.	Status
1	Picture upper left SAW process on weld NSDI SA33A/F-24 A/B			
2	Picture upper right UT on various welds for skin plate SA179.

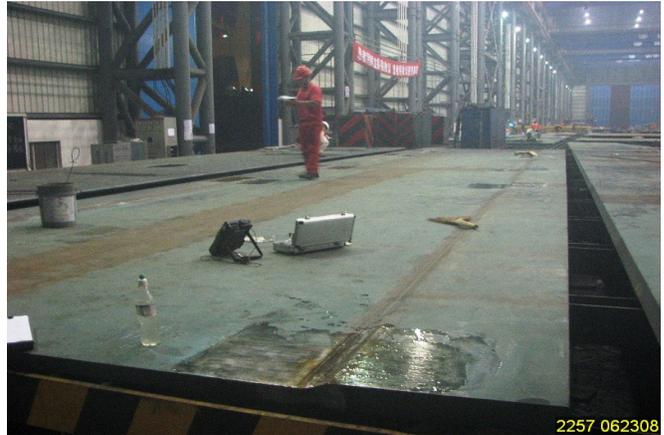
Per ZPMC UT inspection notification (000573) this inspector performed Ultrasonic Testing (UT) verification of the QC UT Inspected and accepted welds. QA Inspector's visual and UT verification appears to be acceptable with AWS D1.5-02 section 6, table 6.3. Reference QA Ultrasonic Test Report TL-6027 dated 6/23/08 for specific test data.
