Quality Assurance and Source Inspection

Contract #: 04-0120F4Cty: SF/ALA Rte: 80 PM: 13.2/13.9File #: 69.28**WELDING INSPECTION REPORT****Resident Engineer:** Pursell, Gary**Address:** 333 Burma Road**City:** Oakland, CA 94607**Report No:** WIR-003051**Date Inspected:** 02-Jun-2008**Project Name:** SAS Superstructure**OSM Arrival Time:** 1430**Prime Contractor:** American Bridge/Fluor Enterprises, a JV**OSM Departure Time:** 2230**Contractor:** Zhenhua Port Machinery Company, Ltd (ZPMC), Changxing Island **Location:** Shanghai, China**CWI Name:** See below**CWI Present:** Yes No**Inspected CWI report:** Yes No N/A**Rod Oven in Use:** Yes No N/A**Electrode to specification:** Yes No N/A**Weld Procedures Followed:** Yes No N/A**Qualified Welders:** Yes No N/A**Verified Joint Fit-up:** Yes No N/A**Approved Drawings:** Yes No N/A**Approved WPS:** Yes No N/A**Delayed / Cancelled:** Yes No N/A**Bridge No:** 34-0006**Component:** Tower and OBG Fabrication**Summary of Items Observed:**

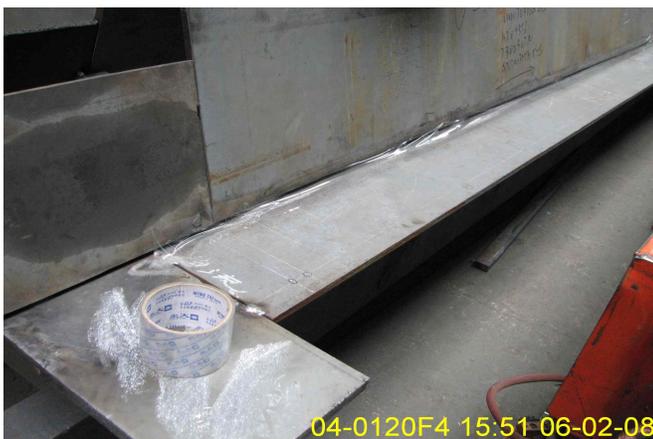
The QA Inspector observed ZPMC personnel installing clear tape over the closed rib tack welded joints of several deck plates. See the photograph below for additional information.

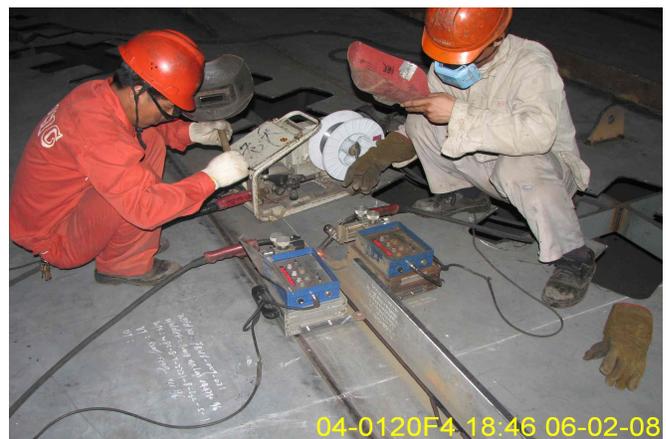
The QA Inspector observed ZPMC welder Mr. Liu Long Xian stencil 44786 is using welding procedure specification WPS-B-T-2132-3 to make flux cored floor beam fillet weld FB016-009-13. The QA Inspector observed a welding current of approximately 330 amps, 30.5 volts and a welding travel speed of 420 mm per minute. On the opposite side of this same plate ZPMC welder Mr. Hong Shuili stencil 44815 is welding

FB016-009-14. The QA Inspector observed a welding current of approximately 300 amps, 29.6 volts and a welding travel speed of 420 mm per minute. Both welders are using motor driven welding machines to progress along opposite sides of the same plate that is being welded. Items observed by the QA Inspector appear to comply with project specifications. See the photograph below for additional information.
