**DEPARTMENT OF TRANSPORTATION**

Contract #: 04-0120F4Cty: SF/ALA Rte: 80 PM: 13.2/13.9File #: 69.28**WELDING INSPECTION REPORT****Resident Engineer:** Pursell, Gary**Address:** 333 Burma Road**City:** Oakland, CA 94607**Report No:** WIR-003231**Date Inspected:** 17-Jul-2008**Project Name:** SAS Superstructure**OSM Arrival Time:** 1400**Prime Contractor:** American Bridge/Fluor Enterprises, a JV**OSM Departure Time:** 2300**Contractor:** Zhenhua Port Machinery Company, Ltd (ZPMC), Changxing Island **Location:** Shanghai, China**CWI Name:** Chen Chih-Ming**CWI Present:** Yes No**Inspected CWI report:** Yes No N/A**Rod Oven in Use:** Yes No N/A**Electrode to specification:** Yes No N/A**Weld Procedures Followed:** Yes No N/A**Qualified Welders:** Yes No N/A**Verified Joint Fit-up:** Yes No N/A**Approved Drawings:** Yes No N/A**Approved WPS:** Yes No N/A**Delayed / Cancelled:** Yes No N/A**Bridge No:** 34-0006**Component:** OBG side, bottom and deck panels**Summary of Items Observed:**

# WELDING INSPECTION REPORT

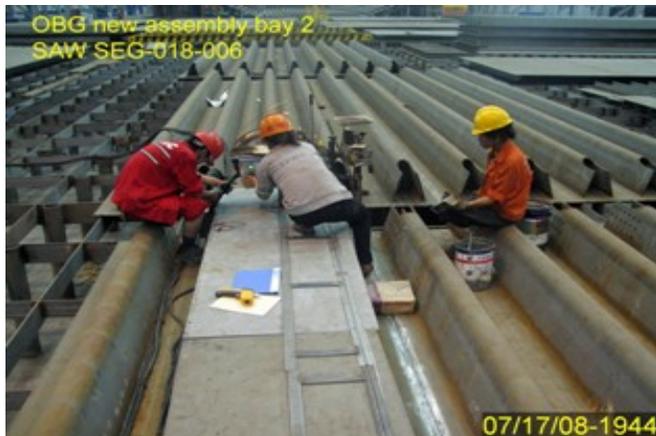
Other general observations include ZPMC personnel fitting and welding OBG east fixture, OBG temporary support columns, grinding and weld bevel prep on various OBG components.
