Contract #: 04-0120F4Cty: SF/ALA Rte: 80 PM: 13.2/13.9File #: 70.28**WELDING INSPECTION REPORT****Resident Engineer:** Pursell, Gary**Address:** 333 Burma Road**City:** Oakland, CA 94607**Report No:** WIR-003258**Date Inspected:** 21-Jul-2008**Project Name:** SAS Superstructure**OSM Arrival Time:** 830**Prime Contractor:** American Bridge/Fluor Enterprises, a JV**OSM Departure Time:** 1730**Contractor:** Japan Steel Works**Location:** Muroran, Japan**CWI Name:** C. Fu-Kuan and M. Ashadi**CWI Present:** Yes No**Inspected CWI report:** Yes No N/A**Rod Oven in Use:** Yes No N/A**Electrode to specification:** Yes No N/A**Weld Procedures Followed:** Yes No N/A**Qualified Welders:** Yes No N/A**Verified Joint Fit-up:** Yes No N/A**Approved Drawings:** Yes No N/A**Approved WPS:** Yes No N/A**Delayed / Cancelled:** Yes No N/A**Bridge No:** 34-0006**Component:** Tower, Deviation and Jacking Saddles**Summary of Items Observed:**

WELDING INSPECTION REPORT

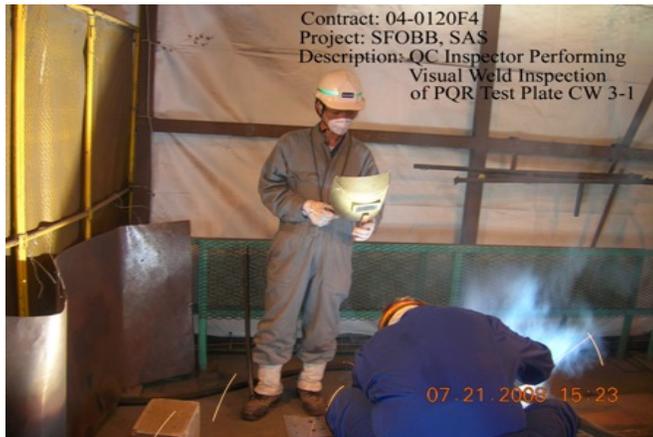
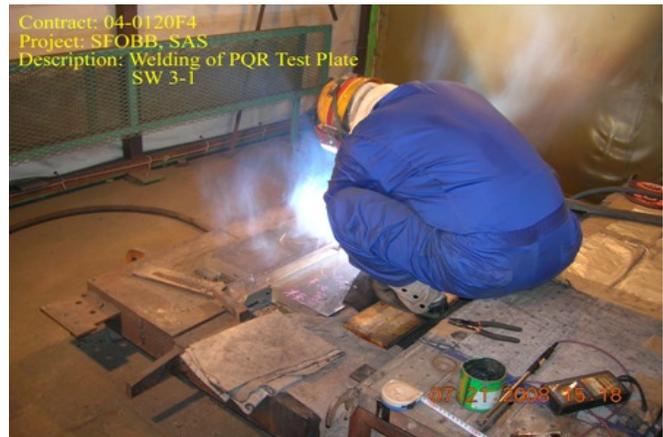
The QA inspector traveled to the Fabrication Shop # 4 at approximately 0900 hours to observe the Magnetic Particle Testing (MPT) of the Partial Joint Penetration (PJP) groove welds and the area of the weld extension plates which were removed and ground to a bright metal. The QA inspector observed several areas at the edge face surface that appeared to be ground to remove linear indications. The excavations are located at the rib plate to base plate connections where the weld extension plates were attached. The depth of the excavations appeared to vary from 2 mm to 11 mm deep. The MPT was performed by Nikko Inspection Services (NIS) technician Kazuya Kobayashi used an AC Yoke utilizing the dry, visible continuous inspection method.

The QA inspector also observed Intertek Testing Services (ITS) Quality Control (QC) personnel Chung Fu-Kuan and Makhmud Ashadi performing a visual weld inspection of the PJP groove welds. There appears to be minor weld repair and weld surfaces requiring grinding of the weld profiles. The MPT and Visual Testing (VT) was not completed during this shift on this date.

At approximately 1400 hours the QA inspector observed the welding of the Procedure Qualification Record (PQR) Test of the test plate identified as SW 3-1 which was performed by the Japan Steel Works, Ltd. (JSW) welding personnel Kobayashi-Kouzou ID 08-5023. The test was performed utilizing the gas shielded Flux Cored Arc Welding (FCAW-G) process as per the Welding Procedure Specification (WPS) SW 4-1. The WPS was also used by the Quality Control (QC) Inspector as a reference.

The following digital photograph illustrates the observations of the activities performed on this date.
