Contract #: 04-0120F4Cty: SF/ALA Rte: 80 PM: 13.2/13.9File #: 69.28**WELDING INSPECTION REPORT****Resident Engineer:** Pursell, Gary**Address:** 333 Burma Road**City:** Oakland, CA 94607**Report No:** WIR-003284**Date Inspected:** 28-Jun-2008**Project Name:** SAS Superstructure**OSM Arrival Time:** 2300**Prime Contractor:** American Bridge/Fluor Enterprises, a JV**OSM Departure Time:** 730**Contractor:** Zhenhua Port Machinery Company, Ltd (ZPMC), Changxing Island **Location:** Changxing Island**CWI Name:** Li Yan Hua**CWI Present:** Yes No**Inspected CWI report:** Yes No N/A**Rod Oven in Use:** Yes No N/A**Electrode to specification:** Yes No N/A**Weld Procedures Followed:** Yes No N/A**Qualified Welders:** Yes No N/A**Verified Joint Fit-up:** Yes No N/A**Approved Drawings:** Yes No N/A**Approved WPS:** Yes No N/A**Delayed / Cancelled:** Yes No N/A**Bridge No:** 34-0006**Component:** OBG**Summary of Items Observed:**

Caltrans Quality Assurance (QA) Inspector, Larry Viars was present to monitor activities associated with the Production Monitoring Test of Orthotropic Box Girder (OBG) Deck Panel U-rib welds, for the San Francisco Oakland Bay Self Anchored Suspension Bridge, at Zhenh

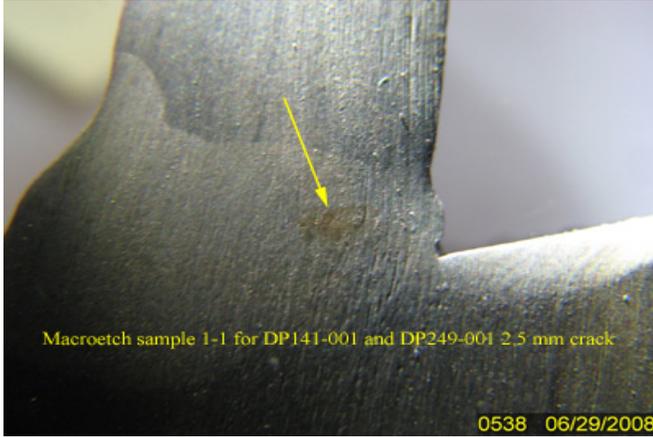
The Caltrans QA Inspector monitored the OBG Production Monitoring Test (PMT) for Deck Panels DP141-001 and DP249-001. The Caltrans QA inspector recorded amperage, voltage and travel speed of the Gas metal Arc Welding (GMAW) root pass and the Submerged Arc Welding (SAW) cover pass. A Visual inspection of the root pass and cover pass was performed by ZPMC, American Bridge Flour (ABF) and the Caltrans QA. The Caltrans QA observed ZPMC QC Mr. Xue Hai Rong perform Ultrasonic testing of the Partial Joint Penetration weld for depth of penetration. Mr. Xue found the PMT welds to be in compliance with contract documents. The Caltrans QA inspector designated locations for Macroetch samples (15 locations). Macroetch samples were evaluated with a 7x optical comparator and sample 1-1 was rejected by ZPMC QC, ABF QC and The Caltrans QA Inspector for a 2.5 mm crack. ZPMC QC stated the PMT for panels DP141-001 and DP249-001 would resume on the following shift. Please see the attached photo of sample 1-1.
