Contract #: 04-0120F4Cty: SF/ALA Rte: 80 PM: 13.2/13.9File #: 69.28**WELDING INSPECTION REPORT****Resident Engineer:** Pursell, Gary**Address:** 333 Burma Road**City:** Oakland, CA 94607**Report No:** WIR-003369**Date Inspected:** 28-Jul-2008**Project Name:** SAS Superstructure**OSM Arrival Time:** 1400**Prime Contractor:** American Bridge/Fluor Enterprises, a JV**OSM Departure Time:** 2300**Contractor:** Zhenhua Port Machinery Company, Ltd (ZPMC), Changxing Island **Location:** Shanghai, China**CWI Name:** Chen Chih-Ming**CWI Present:** Yes No**Inspected CWI report:** Yes No N/A**Rod Oven in Use:** Yes No N/A**Electrode to specification:** Yes No N/A**Weld Procedures Followed:** Yes No N/A**Qualified Welders:** Yes No N/A**Verified Joint Fit-up:** Yes No N/A**Approved Drawings:** Yes No N/A**Approved WPS:** Yes No N/A**Delayed / Cancelled:** Yes No N/A**Bridge No:** 34-0006**Component:** OBG side, bottom and deck panels**Summary of Items Observed:**

WELDING INSPECTION REPORT

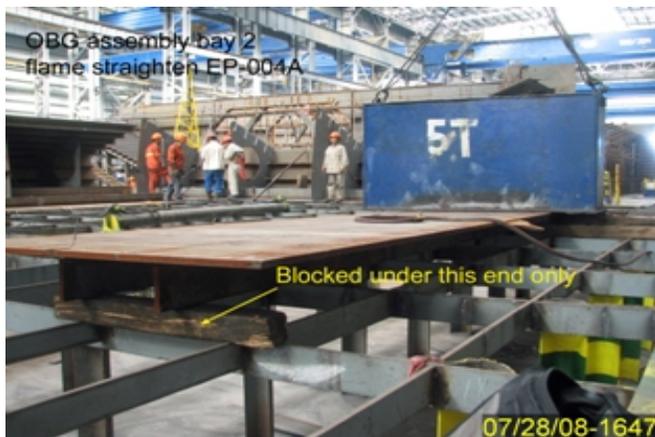
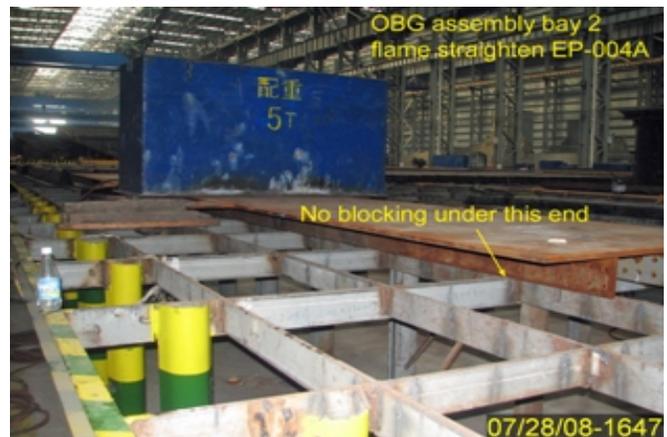
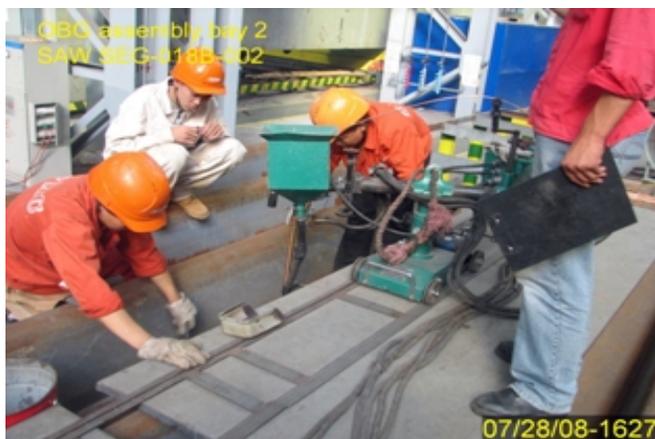
QA observed ZPMC personnel flame straightening EP-004A by blocking up one end of the plate and applying mechanical force and heat. The use of blocks is not referenced in the approved heat straightening procedure in ZPMC's WQCP section 11. An incident report has been generated concerning this discrepancy. See attached photos.
