Contract #: 04-0120F4Cty: SF/ALA Rte: 80 PM: 13.2/13.9File #: 69.28**WELDING INSPECTION REPORT****Resident Engineer:** Pursell, Gary**Address:** 333 Burma Road**City:** Oakland, CA 94607**Report No:** WIR-003408**Date Inspected:** 07-Jul-2008**Project Name:** SAS Superstructure**OSM Arrival Time:** 700**Prime Contractor:** American Bridge/Fluor Enterprises, a JV**OSM Departure Time:** 1500**Contractor:** Zhenhua Port Machinery Company, Ltd (ZPMC), Changxing Island **Location:** Shanghai, China

OBG Bay 3:

WELDING INSPECTION REPORT

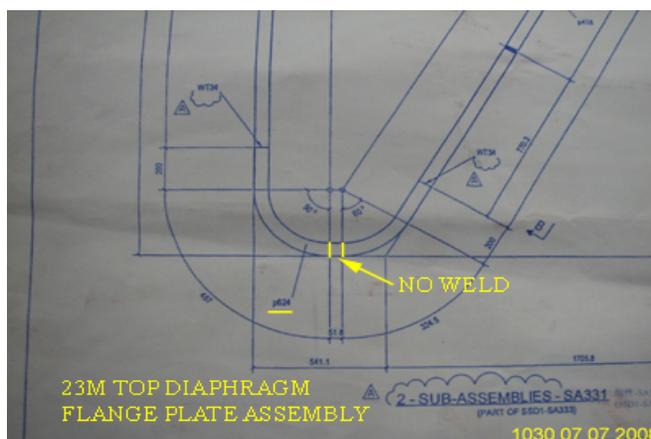
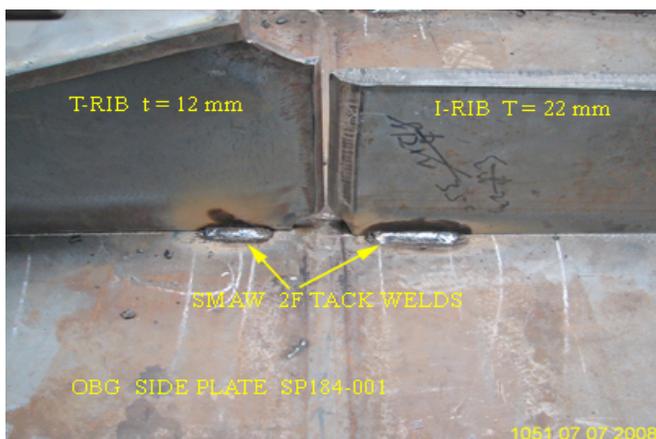
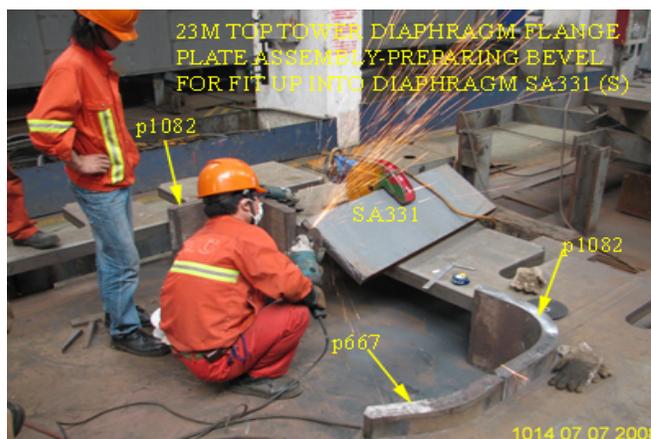
The QA Inspector randomly observed a ZPMC helper utilizing a grinder to prepare the bevels on Diaphragm Flange Plate Assembly SSD1-SA331 piece mark SA331, for fit up into 23M Top Diaphragm SA333(S). The QA Inspector also observed the fit up of Diaphragm flange plate assembly piece marks p667, p1082 and p624. Piece

mark p624 was not in accordance with the Approved Drawing SSD1-SA331. The drawing shows p624 to be one piece. The fit up p624 is made up of 2 pieces with double "V" weld prep. ZPMC QC informed the QA Inspector that this was an approved "Field Change". The QA Inspector verified the "Field Change" with the Caltrans SMR for the Tower. The attached photographs provide additional detail.
