**DEPARTMENT OF TRANSPORTATION**

Contract #: 04-0120F4Cty: SF/ALA Rte: 80 PM: 13.2/13.9File #: 69.28**WELDING INSPECTION REPORT****Resident Engineer:** Pursell, Gary**Address:** 333 Burma Road**City:** Oakland, CA 94607**Report No:** WIR-003415**Date Inspected:** 04-Jul-2008**Project Name:** SAS Superstructure**OSM Arrival Time:** 2300**Prime Contractor:** American Bridge/Fluor Enterprises, a JV**OSM Departure Time:** 730**Contractor:** Zhenhua Port Machinery Company, Ltd (ZPMC), Changxing Island **Location:** Shanghai, China**CWI Name:** Chen Xi**CWI Present:** Yes No**Inspected CWI report:** Yes No N/A**Rod Oven in Use:** Yes No N/A**Electrode to specification:** Yes No N/A**Weld Procedures Followed:** Yes No N/A**Qualified Welders:** Yes No N/A**Verified Joint Fit-up:** Yes No N/A**Approved Drawings:** Yes No N/A**Approved WPS:** Yes No N/A**Delayed / Cancelled:** Yes No N/A**Bridge No:** 34-0006**Component:** OBG, Tower**Summary of Items Observed:**

**Tower (Heavy Machinery Shop – Bay 1**

**OBG Sub-Assembly Shop – Bay 1**

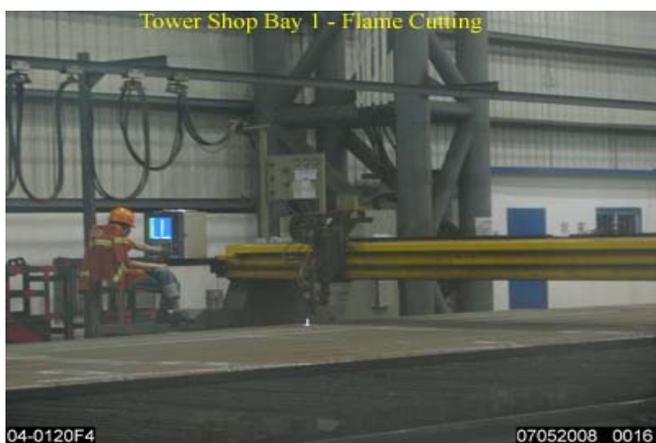
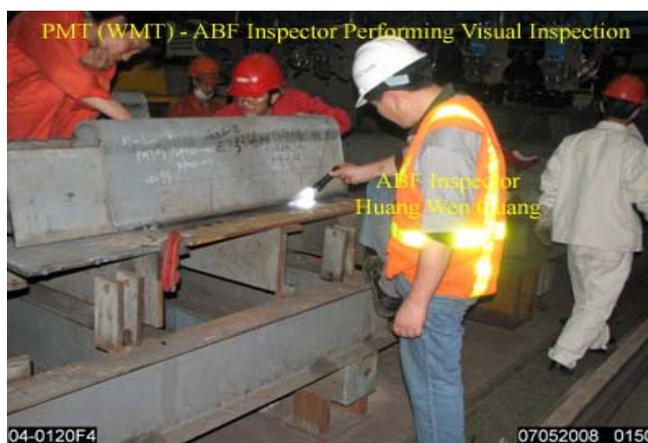
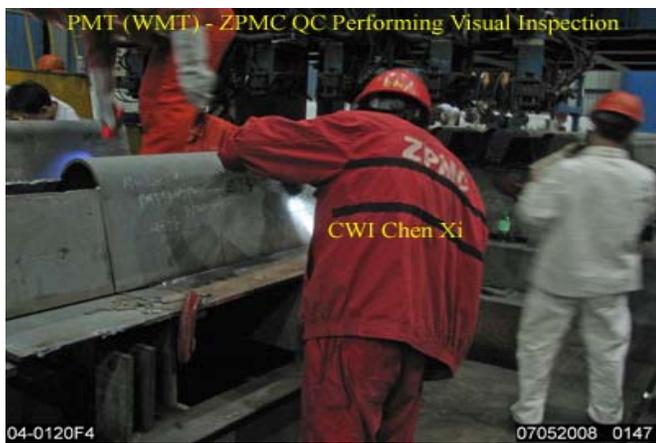
Caltrans Quality Assurance (QA) Inspector, Ken Jobes, was present to monitor activities associated with the Production Monitoring Test (PMT) of Orthotropic Box Girder (OBG) Deck Panel U-rib welds. The PMT representing Deck Panels DP385-001 and DP412-001 was monitored. After magnetic particle examination (MT) of the tack welds was accepted by ZPMC Level II MT Technician, Zhou Dong yun; three ribs (six welds) were simultaneously welded to the simulated deck plate in the horizontal groove (2G) welding position. The Welding

Procedure Specification (WPS) used was WPS-B-T-2342-U1(Urib)-3. It is a combination procedure using gas metal arc welding (GMAW) for the root pass and submerged arc welding (SAW) for the cover or fill pass. The filler metals being used were verified to be as specified on the WPS; 1.4 mm diameter, ER70S-6 (JM-56) for GMAW and 4.8 mm diameter EM12K (JW-3) for SAW. In addition, the specified flux, JF-B was also verified for SAW. During the test, the Caltrans QA Inspector recorded the parameters of amperage, voltage, and travel speed on the U-Ribs PMT Inspection Sheet, dated 07-05-08, for both welding processes. Each of the six welding operators' identification numbers were also recorded on the U-Ribs PMT Inspection Sheet. ZPMC Certified Welding Inspector (CWI), Chen Xi and ABF QA Inspector Huang Wen Guang were present during welding.

The final weld was visually examined and accepted by ZPMC CWI, Chen Xi; and ABF QA Inspector Huang Wen Guang; All welds appeared to meet the specified visual examination acceptance criteria.. After ultrasonic examination (UT) and acceptance by ZPMC Level II UT Technician, Esh Ui qin, the Caltrans QA Inspector designated the locations for the fifteen required macro-etch specimens. All macro-etch specimens were prepared and found acceptable by ZPMC CWI, and ABF QA Inspector. The macro-etch specimens were then examined by the Caltrans QA Inspector and the depth of penetration on each measured and the results recorded on Caltrans Project 04-0120F4 SAS OBG Fabrication Macro Etch Log.
