**DEPARTMENT OF TRANSPORTATION**

Contract #: 04-0120F4Cty: SF/ALA Rte: 80 PM: 13.2/13.9File #: 69.28**WELDING INSPECTION REPORT****Resident Engineer:** Pursell, Gary**Address:** 333 Burma Road**City:** Oakland, CA 94607**Report No:** WIR-003420**Date Inspected:** 14-Jul-2008**Project Name:** SAS Superstructure**OSM Arrival Time:** 2230**Prime Contractor:** American Bridge/Fluor Enterprises, a JV**OSM Departure Time:** 730**Contractor:** Zhenhua Port Machinery Company, Ltd (ZPMC), Changxing Island **Location:** Shanghai, China**CWI Name:** Li Yan Hui**CWI Present:** Yes No**Inspected CWI report:** Yes No N/A**Rod Oven in Use:** Yes No N/A**Electrode to specification:** Yes No N/A**Weld Procedures Followed:** Yes No N/A**Qualified Welders:** Yes No N/A**Verified Joint Fit-up:** Yes No N/A**Approved Drawings:** Yes No N/A**Approved WPS:** Yes No N/A**Delayed / Cancelled:** Yes No N/A**Bridge No:** 34-0006**Component:** OBG, Tower**Summary of Items Observed:**

# WELDING INSPECTION REPORT

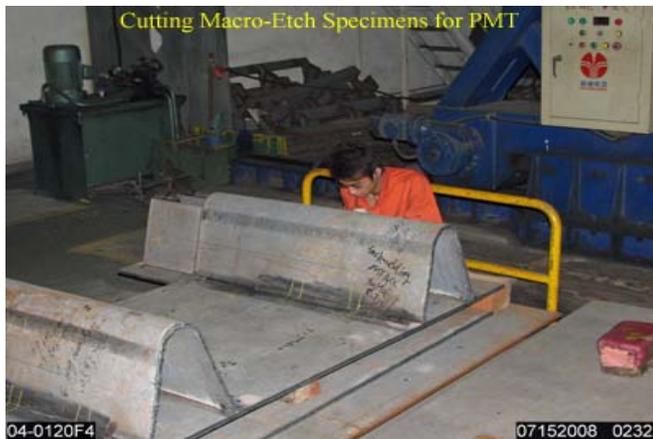
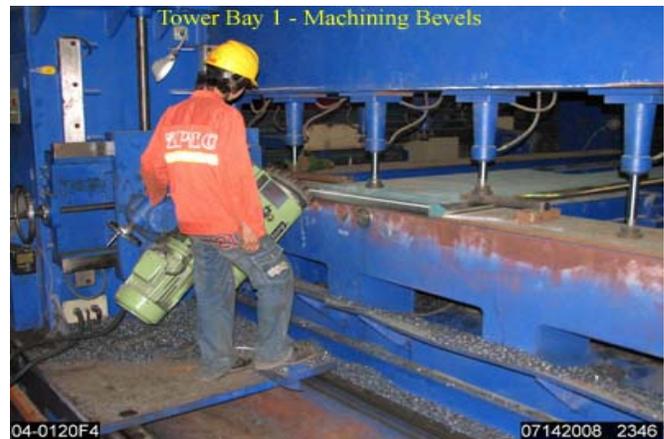
Production Monitoring Test (PMT) of Orthotropic Box Girder (OBG) Deck Panel U-rib welds. The PMT representing Deck Panels DP495-001 and DP306-001 was monitored. After MT of the tack welds was accepted by ZPMC Level II MT Technician, Xu Hai, two ribs (four welds) were simultaneously welded to the simulated deck plate in the horizontal groove (2G) welding position. The Welding Procedure Specification (WPS) used was WPS-B-T-2342-U1(Urib)-3. It is a combination procedure using gas metal arc welding (GMAW) for the root pass and submerged arc welding (SAW) for the cover or fill pass. The filler metals being used were verified to be as specified on the WPS; 1.4 mm diameter, ER70S-6 (JM-56) for GMAW and 4.8 mm diameter EM12K (JW-3) for SAW. In addition, the specified flux, JF-B was also verified for SAW. During the test, the Caltrans QA Inspector recorded the parameters of amperage, voltage, and travel speed on the U-Ribs PMT Inspection Sheet, dated 07-15-08, for both welding processes. Each of the four welding operators' identification numbers were also recorded on the U-Ribs PMT Inspection Sheet. ZPMC Certified Welding Inspector (CWI), Li Yan Hui and ABF QA Inspector Lv Yun were present during welding.

The final weld was visually examined and accepted by ZPMC CWI, Li Yan Hui; and ABF QA Inspector Lv Yun. All welds appeared to meet the specified visual examination acceptance criteria.. After ultrasonic examination (UT) and acceptance by ZPMC Level II UT Technician, Xue Hai Rong, the Caltrans QA Inspector designated the locations for the ten required macro-etch specimens. All macro-etch specimens were prepared and found acceptable by ZPMC CWI, and ABF QA Inspector. The macro-etch specimens were then examined by the Caltrans QA Inspector and the depth of penetration on each measured and the results recorded on Caltrans Project 04-0120F4 SAS OBG Fabrication Macro Etch Log.

All above observations appeared to meet the requirements of the job specifications.
