**DEPARTMENT OF TRANSPORTATION**

Contract #: 04-0120F4Cty: SF/ALA Rte: 80 PM: 13.2/13.9File #: 69.28**WELDING INSPECTION REPORT****Resident Engineer:** Pursell, Gary**Address:** 333 Burma Road**City:** Oakland, CA 94607**Report No:** WIR-003427**Date Inspected:** 25-Jul-2008**Project Name:** SAS Superstructure**OSM Arrival Time:** 2300**Prime Contractor:** American Bridge/Fluor Enterprises, a JV**OSM Departure Time:** 730**Contractor:** Zhenhua Port Machinery Company, Ltd (ZPMC), Changxing Island **Location:** Shanghai, China**CWI Name:** Chen Xi, An Qing Xiang**CWI Present:** Yes No**Inspected CWI report:** Yes No N/A**Rod Oven in Use:** Yes No N/A**Electrode to specification:** Yes No N/A**Weld Procedures Followed:** Yes No N/A**Qualified Welders:** Yes No N/A**Verified Joint Fit-up:** Yes No N/A**Approved Drawings:** Yes No N/A**Approved WPS:** Yes No N/A**Delayed / Cancelled:** Yes No N/A**Bridge No:** 34-0006**Component:** OBG**Summary of Items Observed:**

**New Tower Bay 2**

**OBG Sub-Assembly Shop – Bay 1**

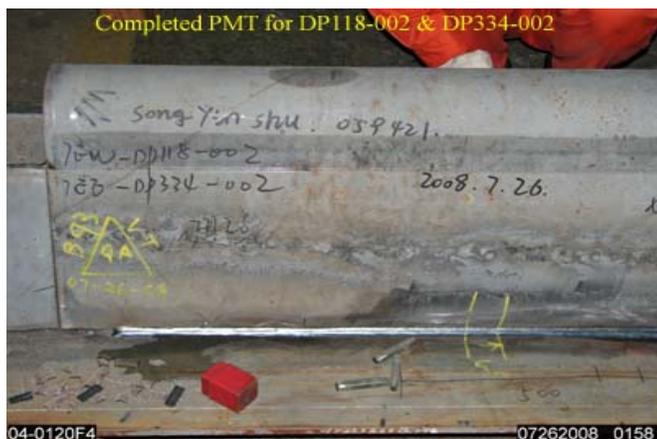
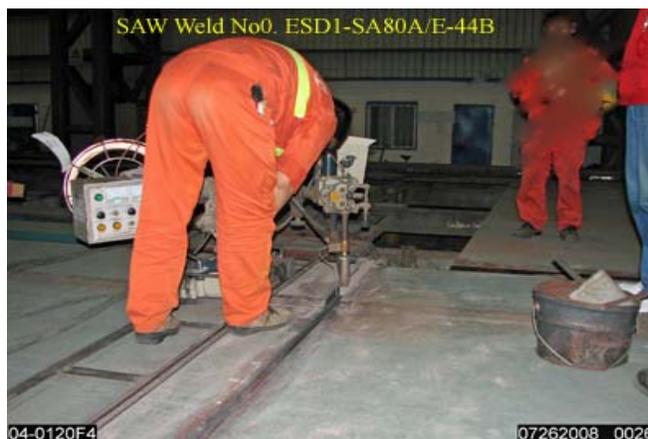
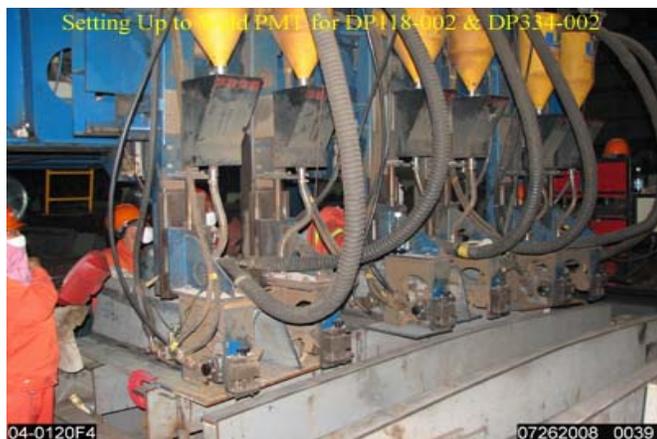
Caltrans Quality Assurance (QA) Inspector, Ken Jobes, was present to monitor activities associated with the Production Monitoring Test (PMT) of Orthotropic Box Girder (OBG) Deck Panel U-rib welds. The PMT representing Deck Panels DP118-002 and DP334-002 was monitored. After MT of the tack welds was accepted by ZPMC Level II MT Technician, Cai Xin Xin, the three ribs (six welds) were simultaneously welded to the

simulated deck plate in the horizontal groove (2G) welding position. The Welding Procedure Specification (WPS) used was WPS-B-T-2342-U1(Urib)-4. It is a combination procedure using gas metal arc welding (GMAW) for the root pass and submerged arc welding (SAW) for the cover or fill pass. The filler metals being used were verified to be as specified on the WPS; 1.4 mm diameter, ER70S-6 (JM-56) for GMAW and 4.8 mm diameter EH14 (H14) for SAW. During the test, the Caltrans QA Inspector recorded the parameters of amperage, voltage, and travel speed on the U-Ribs PMT Inspection Sheet, dated 07-26-08, for both welding processes. The name of the gantry operator and each of the six welding operators' identification numbers were also recorded on the U-Ribs PMT Inspection Sheet. ZPMC Certified Welding Inspector (CWI), Chen Xi and ABF QA Inspector Whang Zhen Hua were present during welding.

The final weld was visually examined and accepted by ZPMC CWI, Chen Xi; and ABF QA Inspector Whang Zhen Hua. All welds appeared to meet the specified visual examination acceptance criteria.. After ultrasonic examination (UT) and acceptance by ZPMC Level II UT Technician, Ma Ji Long, the Caltrans QA Inspector designated the locations for the fifteen required macro-etch specimens. All macro-etch specimens were prepared and found acceptable by ZPMC CWI, and ABF QA Inspector. The macro-etch specimens were then examined by the Caltrans QA Inspector and the depth of penetration on each measured and the results recorded on Caltrans Project 04-0120F4 SAS OBG Fabrication Macro Etch Log.

All above observations appeared to meet the requirements of the job specifications.
