DEPARTMENT OF TRANSPORTATION

Contract #: 04-0120F4Cty: SF/ALA Rte: 80 PM: 13.2/13.9File #: 70.28**WELDING INSPECTION REPORT****Resident Engineer:** Pursell, Gary**Address:** 333 Burma Road**City:** Oakland, CA 94607**Report No:** WIR-003441**Date Inspected:** 11-Aug-2008**Project Name:** SAS Superstructure**OSM Arrival Time:** 800**Prime Contractor:** American Bridge/Fluor Enterprises, a JV**OSM Departure Time:** 1630**Contractor:** Japan Steel Works**Location:** Muroran, Japan**CWI Name:** Chung Fu-Kuan**CWI Present:** Yes No**Inspected CWI report:** Yes No N/A**Rod Oven in Use:** Yes No N/A**Electrode to specification:** Yes No N/A**Weld Procedures Followed:** Yes No N/A**Qualified Welders:** Yes No N/A**Verified Joint Fit-up:** Yes No N/A**Approved Drawings:** Yes No N/A**Approved WPS:** Yes No N/A**Delayed / Cancelled:** Yes No N/A**Bridge No:** 34-0006**Component:** Tower, Deviation and Jacking Saddles**Summary of Items Observed:**

WELDING INSPECTION REPORT

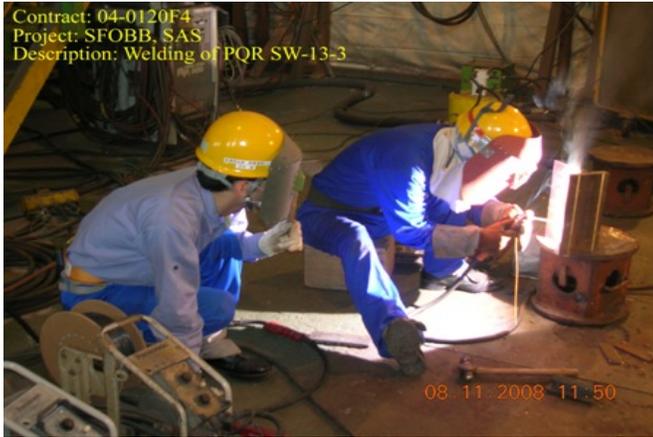
Later in the shift the QA inspector traveled to the Fabrication Shop # 4 to observe the continued Partial Joint Penetration (PJP) groove welding of the structural steel plate components for the West Deviation Saddle identified as W2E2. The Welding Procedure Specifications (WPS) SJ-3011-2, SJ-3011-3 and the Distortion Control Plan, identified as Document SJ-3109 Revision 3 was utilized by the Japan Steel Works, Ltd. (JSW) personnel during the performance of the production welding of the rib plate to base plate connection identified as EY2-15L, EY2-15V, EY2-16L, EY2-16V and EY2-9L. The WPS and the Distortion Control Plan were also used as a reference during QC verification of the welding parameters and the monitoring of the weld sequence. The production welding sequence was performed as per Attachment 5, Case 2 Step 2 and Attachment 6, Step 3 of the Distortion Control Plan. The welding was performed in the Flat (1G) Position with the work in the horizontal plane and the weld metal deposited from above.

The digital photographs on Page 3 of this report illustrates the observations of the activities performed on this date.
