DEPARTMENT OF TRANSPORTATION

Quality Assurance and Source Inspection

Contract #: 04-0120F4Cty: SF/ALA Rte: 80 PM: 13.2/13.9File #: 69.28**WELDING INSPECTION REPORT****Resident Engineer:** Pursell, Gary**Address:** 333 Burma Road**City:** Oakland, CA 94607**Report No:** WIR-003447**Date Inspected:** 16-Jul-2008**Project Name:** SAS Superstructure**OSM Arrival Time:** 700**Prime Contractor:** American Bridge/Fluor Enterprises, a JV**OSM Departure Time:** 1530**Contractor:** Zhenhua Port Machinery Company, Ltd (ZPMC), Changxing Island **Location:** Shanghai, China**CWI Name:** See Below**CWI Present:** Yes No**Inspected CWI report:** Yes No N/A**Rod Oven in Use:** Yes No N/A**Electrode to specification:** Yes No N/A**Weld Procedures Followed:** Yes No N/A**Qualified Welders:** Yes No N/A**Verified Joint Fit-up:** Yes No N/A**Approved Drawings:** Yes No N/A**Approved WPS:** Yes No N/A**Delayed / Cancelled:** Yes No N/A**Bridge No:** 34-0006**Component:** Tower & OBG**Summary of Items Observed:**

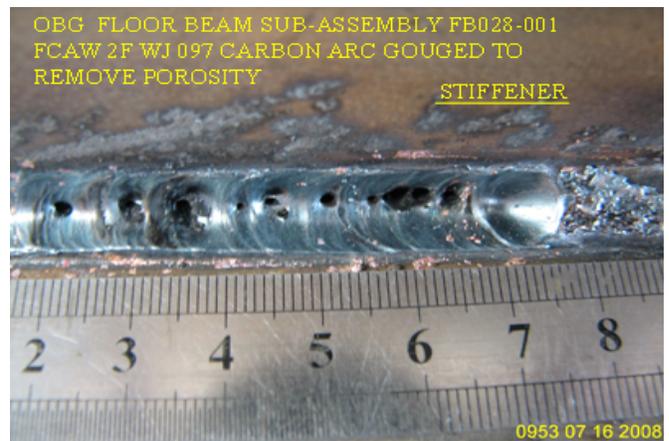
The QA Inspector randomly observed ZPMC welding personnel utilizing the Carbon Air Arc Gouging Process to remove deposited weld metal containing porosity in numerous FCAW 2F welds attaching various stiffeners to Floor Beam Sub-Assembly FB028-001. The QA Inspector randomly observed that many of the gouged areas still contained rejectable porosity at gouged depths up to 3 mm. The QA Inspector randomly observed ZPMC CWI Hu Wei Qing monitoring to work. The attached photographs provide additional detail.
