DEPARTMENT OF TRANSPORTATION

Quality Assurance and Source Inspection

Contract #: 04-0120F4Cty: SF/ALA Rte: 80 PM: 13.2/13.9File #: 69.28**WELDING INSPECTION REPORT****Resident Engineer:** Pursell, Gary**Address:** 333 Burma Road**City:** Oakland, CA 94607**Report No:** WIR-003451**Date Inspected:** 28-Jul-2008**Project Name:** SAS Superstructure**OSM Arrival Time:** 700**Prime Contractor:** American Bridge/Fluor Enterprises, a JV**OSM Departure Time:** 1530**Contractor:** Zhenhua Port Machinery Company, Ltd (ZPMC), Changxing Island **Location:** Shanghai, China**CWI Name:** Li Yanhua**CWI Present:** Yes No**Inspected CWI report:** Yes No N/A**Rod Oven in Use:** Yes No N/A**Electrode to specification:** Yes No N/A**Weld Procedures Followed:** Yes No N/A**Qualified Welders:** Yes No N/A**Verified Joint Fit-up:** Yes No N/A**Approved Drawings:** Yes No N/A**Approved WPS:** Yes No N/A**Delayed / Cancelled:** Yes No N/A**Bridge No:** 34-0006**Component:** OBG**Summary of Items Observed:**

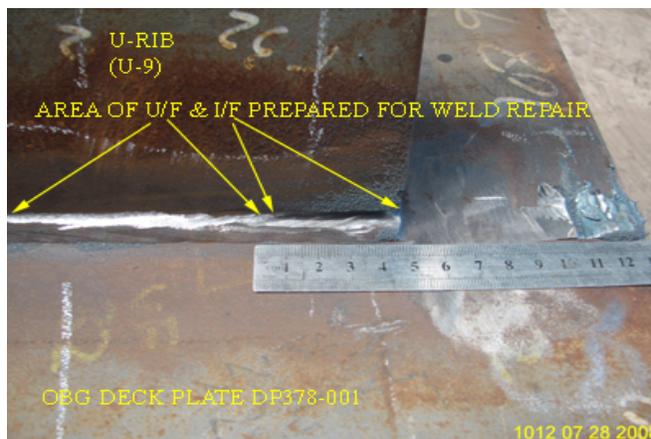
The QA Inspector randomly observed a ZPMC helper utilizing an angle grinder to prepare the welds attaching U-Ribs to Deck Plate DP378-001 (DP378-Yellow Tag 000259) for weld repair. These areas contain defects and had been previously marked up by ZPMC QC. The attached photograph provides additional detail.
