**DEPARTMENT OF TRANSPORTATION**

Contract #: 04-0120F4Cty: SF/ALA Rte: 80 PM: 13.2/13.9File #: 69.28**WELDING INSPECTION REPORT****Resident Engineer:** Pursell, Gary**Address:** 333 Burma Road**City:** Oakland, CA 94607**Report No:** WIR-003452**Date Inspected:** 29-Jul-2008**Project Name:** SAS Superstructure**OSM Arrival Time:** 700**Prime Contractor:** American Bridge/Fluor Enterprises, a JV**OSM Departure Time:** 1530**Contractor:** Zhenhua Port Machinery Company, Ltd (ZPMC), Changxing Island **Location:** Shanghai, China**CWI Name:** See below**CWI Present:** Yes No**Inspected CWI report:** Yes No N/A**Rod Oven in Use:** Yes No N/A**Electrode to specification:** Yes No N/A**Weld Procedures Followed:** Yes No N/A**Qualified Welders:** Yes No N/A**Verified Joint Fit-up:** Yes No N/A**Approved Drawings:** Yes No N/A**Approved WPS:** Yes No N/A**Delayed / Cancelled:** Yes No N/A**Bridge No:** 34-0006**Component:** Tower & OBG**Summary of Items Observed:**

## WELDING INSPECTION REPORT

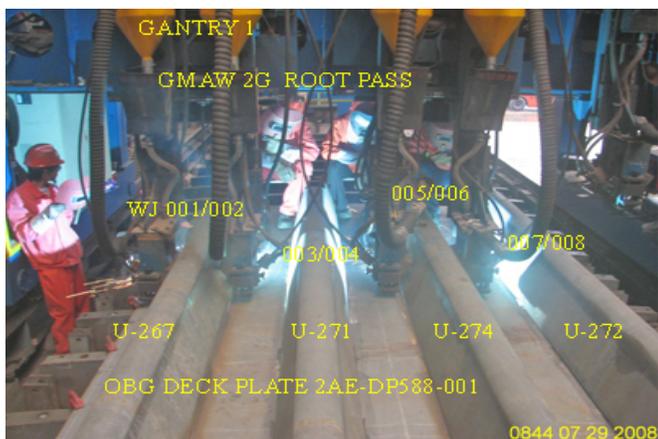
The QA Inspector randomly observed ZPMC welders Xiang Huan Feng ID Number 059416, Xiang Jie ID Number 059378, Gao Xin Dong ID Number 059361 and Jiang Ting Guang ID Number 062265, utilizing Gantry 1 mounted welding apparatus with the Gas Metal Arc Welding (GMAW) Process in the 2G (Horizontal Groove) Position with ZPMC Weld Procedure Specification (WPS) WPS-B-T-2342-U1(U-Rib)-3, to weld the root pass of the U-Ribs to 4 Rib Deck Plate Sub-Assembly 2AE-DP588-001 at Weld Joint (WJ) Numbers DP588-001-001/002(U-267) and 005/006(U-279). The QA Inspector randomly observed ZPMC QC monitoring weld parameters (CWI Sun Wei). The QA Inspector also randomly monitored weld parameters and recorded them as follows: 363/373 amps, 30.9/30.2 volts (WJ's 001/002) for Mr. Xiang/Mr. Jiang; and 370/363 amps, 30.5/30.4 volts (WJ's 005/006) for Mr. Gao/Mr. Jiang with a travel speed of 537 millimeters (mm) per minute for all welders.

The weld parameters appeared to comply with contract requirements. The attached photograph provides additional detail.

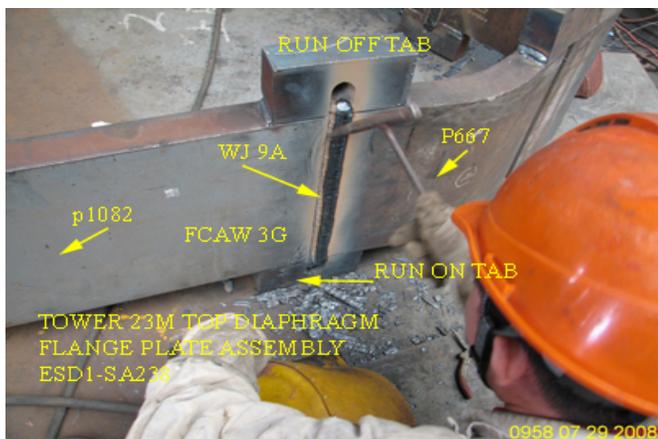
The QA Inspector randomly observed ZPMC welders ID Numbers 037705, 066401 and 066239 utilizing the FCAW Process in the 3G (Vertical Groove) Position with ZPMC WPS WPS-B-T-2233-U3-F, to weld the butt splice of 23M Top Tower Diaphragm Flange Plate Assembly ESD1-SA238. The QA Inspector randomly observed ZPMC CWI Yi Yong Jun monitoring weld parameters. The QA Inspector also randomly monitored weld parameters and recorded them as follows: 215 amps, 26 volts, travel speed 118 mm/min for welder ID 037705 (WJ 11A); 216 amps, 26 volts, travel speed 118 mm/min for ID 066401 (WJ 7A) and 217 amps, 26 volts, travel speed 117 mm/min for welder ID 066239 (WJ 9A). The weld parameters appeared to comply with contract requirements. The attached photograph provides additional detail.
