Contract #: 04-0120F4Cty: SF/ALA Rte: 80 PM: 13.2/13.9File #: 69.28**WELDING INSPECTION REPORT****Resident Engineer:** Pursell, Gary**Address:** 333 Burma Road**City:** Oakland, CA 94607**Report No:** WIR-003484**Date Inspected:** 14-Jul-2008**Project Name:** SAS Superstructure**OSM Arrival Time:** 1400**Prime Contractor:** American Bridge/Fluor Enterprises, a JV**OSM Departure Time:** 2200**Contractor:** Zhenhua Port Machinery Company, Ltd (ZPMC), Changxing Island **Location:** Shanghai China**CWI Name:** Li Yun Hua**CWI Present:** Yes No**Inspected CWI report:** Yes No N/A**Rod Oven in Use:** Yes No N/A**Electrode to specification:** Yes No N/A**Weld Procedures Followed:** Yes No N/A**Qualified Welders:** Yes No N/A**Verified Joint Fit-up:** Yes No N/A**Approved Drawings:** Yes No N/A**Approved WPS:** Yes No N/A**Delayed / Cancelled:** Yes No N/A**Bridge No:** 34-0006**Component:** OBG**Summary of Items Observed:**

Deck Panel Repair Area 2 (yard)

Tower Shop Bay 3 Deck Panel repairs

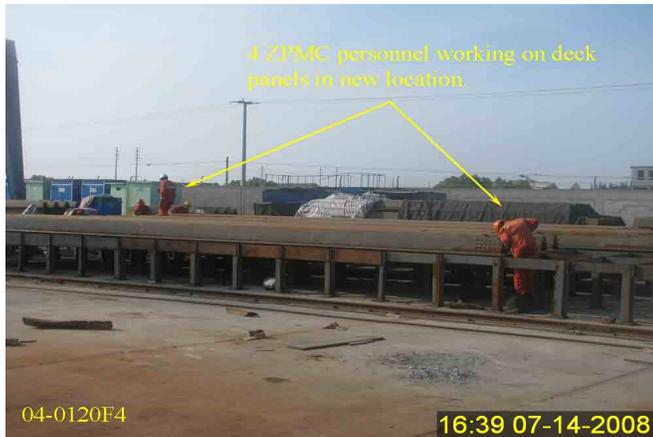
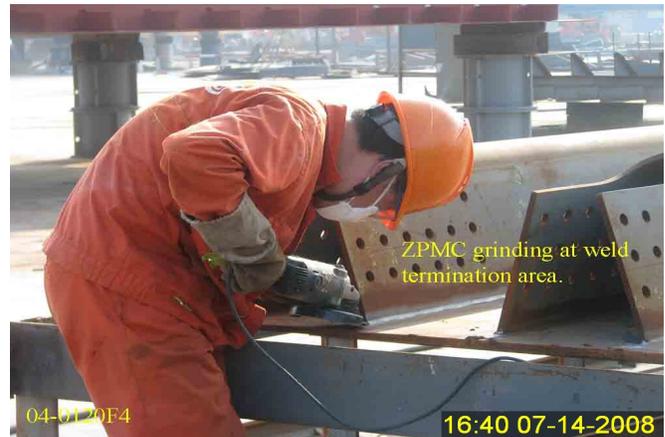
The QA Inspector randomly observed ZPMC personnel performing grinding of repairs for the Orthotropic Box Girder (OBG) deck panel Partial Joint Penetration (PJP) welds. During initial observations it was noted that twenty-two (22 ea) deck panels are inside the shop. This QA inspector observed the repair grinding on the following deck panels; DP245-001, DP272-001, DP191-001 and DP488-001 these were in process for the remainder of this shift. This QA inspector requested from ZPMC that deck panel Dp083-001 be un-stacked and available for Caltrans to perform an initial visual inspection. ZPMC informed Caltrans that they would have the

panel available by the day shift which was agreeable. Certified Welding Inspector for ZPMC Li Yun Hua was present at this location for the monitoring of the deck repairs and inspection. Also noted in bay 3 to monitor deck panel repairs were ABF personnel Kevin Chen, Wang Zhong Yuan and Ding Bao Hua.
