DEPARTMENT OF TRANSPORTATION

Contract #: 04-0120F4
Cty: SF/ALA Rte: 80 PM: 13.2/13.9
File #: 70.28

WELDING INSPECTION REPORT**Resident Engineer:** Pursell, Gary**Address:** 333 Burma Road**City:** Oakland, CA 94607**Report No:** WIR-003544**Date Inspected:** 20-Aug-2008**Project Name:** SAS Superstructure**Prime Contractor:** American Bridge/Fluor Enterprises, a JV**Contractor:** Japan Steel Works**OSM Arrival Time:** 800**OSM Departure Time:** 1630**Location:** Muroran, Japan**CWI Name:** Chung Fu-Kuan**CWI Present:** Yes No**Inspected CWI report:** Yes No N/A**Rod Oven in Use:** Yes No N/A**Electrode to specification:** Yes No N/A**Weld Procedures Followed:** Yes No N/A**Qualified Welders:** Yes No N/A**Verified Joint Fit-up:** Yes No N/A**Approved Drawings:** Yes No N/A**Approved WPS:** Yes No N/A**Delayed / Cancelled:** Yes No N/A**Bridge No:** 34-0006**Component:** Tower, Deviation and Jacking Saddles**Summary of Items Observed:**

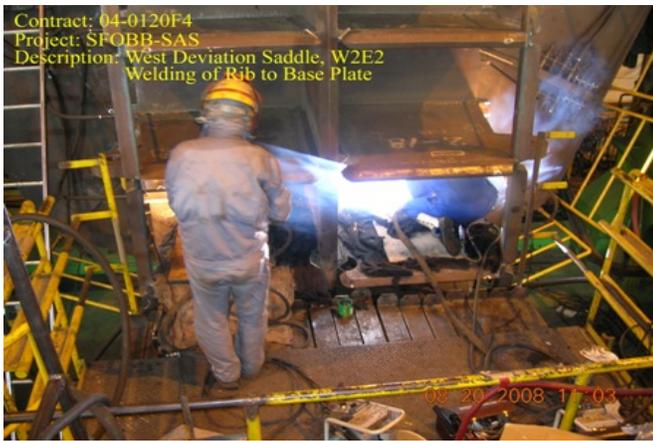
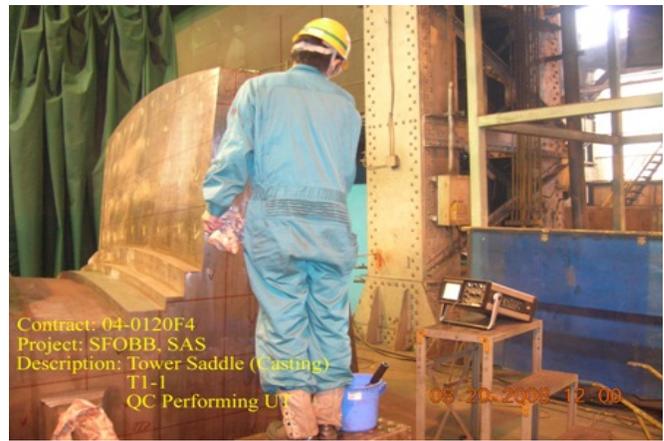
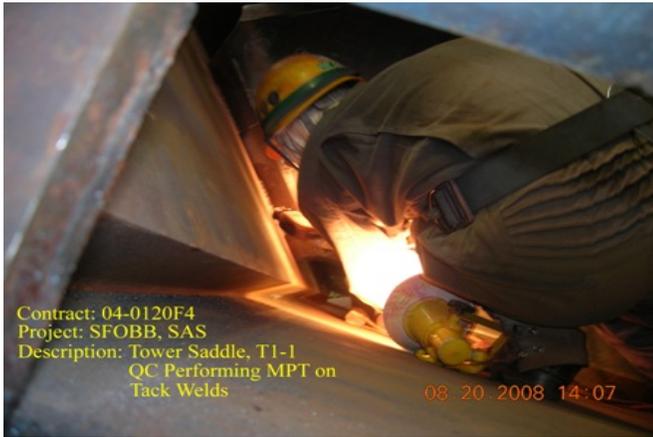
On this page of this report, see Weld Joints in Progress Inspected regarding the QA observations of the production welding parameters recorded and the digital photographs which illustrates the observations of the activities performed on this date.
