DEPARTMENT OF TRANSPORTATION

Quality Assurance and Source Inspection

Contract #: 04-0120F4Cty: SF/ALA Rte: 80 PM: 13.2/13.9File #: 69.28**WELDING INSPECTION REPORT****Resident Engineer:** Pursell, Gary**Address:** 333 Burma Road**City:** Oakland, CA 94607**Report No:** WIR-003550**Date Inspected:** 20-Aug-2008**Project Name:** SAS Superstructure**OSM Arrival Time:** 1400**Prime Contractor:** American Bridge/Fluor Enterprises, a JV**OSM Departure Time:** 2300**Contractor:** Zhenhua Port Machinery Company, Ltd (ZPMC), Changxing Island **Location:** Shanghai, China**CWI Name:** Chen Chih Ming**CWI Present:** Yes No**Inspected CWI report:** Yes No N/A**Rod Oven in Use:** Yes No N/A**Electrode to specification:** Yes No N/A**Weld Procedures Followed:** Yes No N/A**Qualified Welders:** Yes No N/A**Verified Joint Fit-up:** Yes No N/A**Approved Drawings:** Yes No N/A**Approved WPS:** Yes No N/A**Delayed / Cancelled:** Yes No N/A**Bridge No:** 34-0006**Component:** OBG side, bottom and deck panels**Summary of Items Observed:**

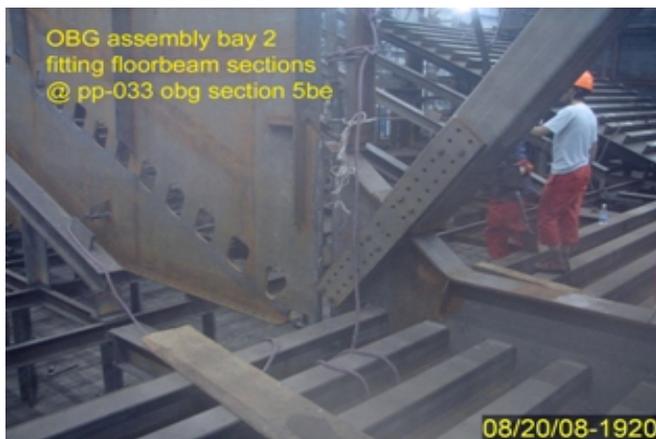
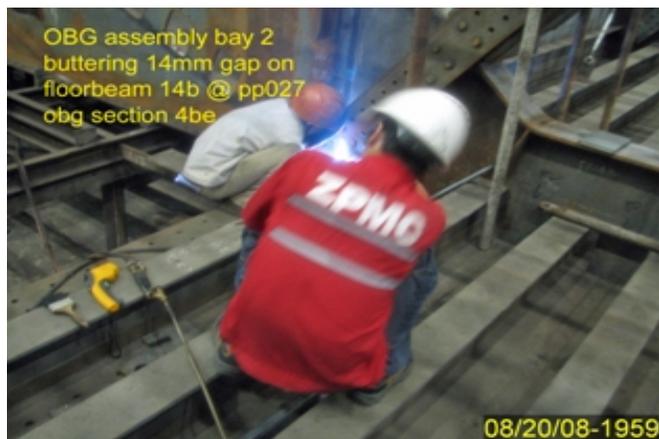
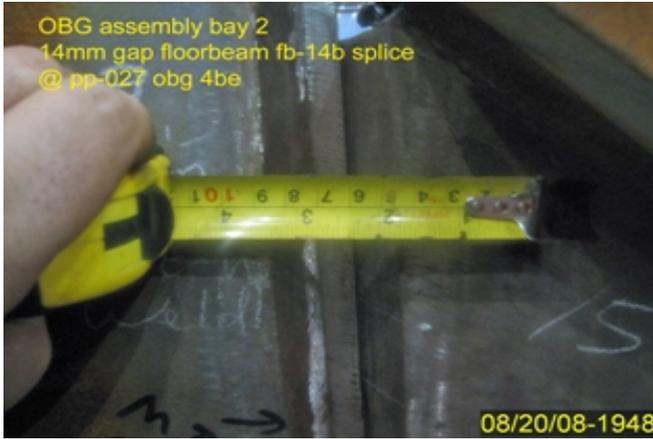
QA observed ZPMC qualified welding personnel build-up by welding (buttering) one edge of floor beam FB 14B @ PP-027 OBG section 4BE in order to close up an excessive root opening of 14mm at the weld joint between the north side floor beam section and the center floor beam section. The welder followed the guide lines of WPS-B-T-2233-B-U2c-F-1. ZPMC CWI identified as Mr. Chen Chih Ming as well as one ABF inspector were on hand to monitor the process. QC recorded the parameters on weld repair report# B-WR779. The welder ID and welding parameters as measured with Quality Controls calibrated instruments appeared to be in conformance with the posted WPS's and were as follows:

QA observed ZPMC qualified welding personnel perform FCAW on the root pass of joint SEG-020-002 joining deck panels DP-042 and DP-080 following the guide lines of WPS-B-T-2231-B-U2-F-1. QC monitored the welding process continuously through out the evening. The welder ID and welding parameters as measured with Quality Controls calibrated instruments appeared to be in conformance with the posted WPS's and were as follows:

QA observed ZPMC qualified welding personnel SAW SEG-013-005 joining DP-052A to DP-002A following the guide lines of WPS-B-T-2221-B-L2c-S-2. QC monitored the welding process continuously through out the evening. The welder ID and welding parameters as measured with Quality Controls calibrated instruments appeared to be in conformance with the posted WPS's and were as follows:
