DEPARTMENT OF TRANSPORTATION

Quality Assurance and Source Inspection

Contract #: 04-0120F4Cty: SF/ALA Rte: 80 PM: 13.2/13.9File #: 69.28**WELDING INSPECTION REPORT****Resident Engineer:** Pursell, Gary**Address:** 333 Burma Road**City:** Oakland, CA 94607**Report No:** WIR-003628**Date Inspected:** 01-Aug-2008**Project Name:** SAS Superstructure**OSM Arrival Time:** 2230**Prime Contractor:** American Bridge/Fluor Enterprises, a JV**OSM Departure Time:** 730**Contractor:** Zhenhua Port Machinery Company, Ltd (ZPMC), Changxing Island **Location:** Shanghai, China**CWI Name:** See below**CWI Present:** Yes No**Inspected CWI report:** Yes No N/A**Rod Oven in Use:** Yes No N/A**Electrode to specification:** Yes No N/A**Weld Procedures Followed:** Yes No N/A**Qualified Welders:** Yes No N/A**Verified Joint Fit-up:** Yes No N/A**Approved Drawings:** Yes No N/A**Approved WPS:** Yes No N/A**Delayed / Cancelled:** Yes No N/A**Bridge No:** 34-0006**Component:** OBG Fabrication**Summary of Items Observed:**

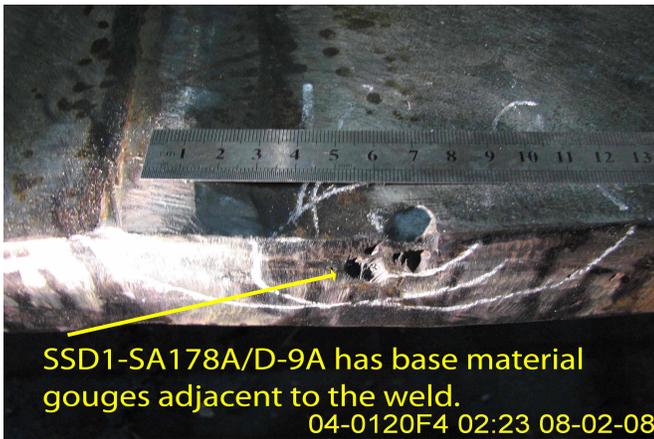
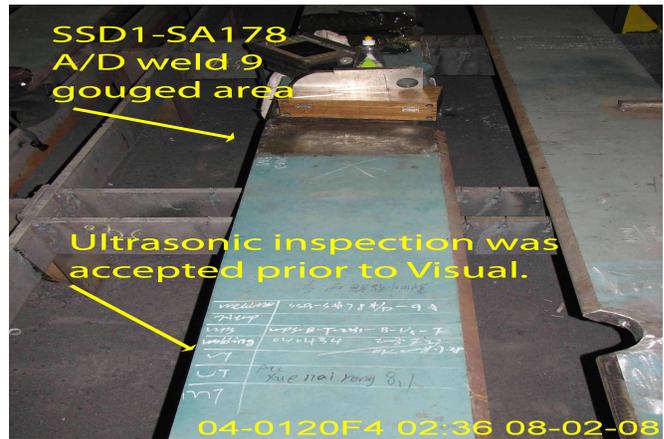
Tower Stiffener weld SSD1-SA178A/D-9 has several 4 & 5 mm deep gouges in the base material approximately 25 mm from the edge of the weld and the end surface of the weld is approximately 5mm below the adjacent surfaces of the edge of the plates. This weld has been ultrasonically accepted by ZPMC personnel the weld does not have any marking to indicate it has been visually accepted by ZPMC QC personnel. AWS requires the weld to

be visually accepted prior to conducting NDE/ultrasonic inspections. ABF Inspector Mr. Liu Cheng and ZPMC QC inspector Mr. Shen Xuejun were informed of these problems and Mr. Xuejun said ZPMC will repair this weld and an additional UT inspection will need to be performed. See the photographs below for additional information.
