Contract #: 04-0120F4Cty: SF/ALA Rte: 80 PM: 13.2/13.9File #: 69.28**WELDING INSPECTION REPORT****Resident Engineer:** Pursell, Gary**Address:** 333 Burma Road**City:** Oakland, CA 94607**Report No:** WIR-003675**Date Inspected:** 15-Aug-2008**Project Name:** SAS Superstructure**OSM Arrival Time:** 1400**Prime Contractor:** American Bridge/Fluor Enterprises, a JV**OSM Departure Time:** 2230**Contractor:** Zhenhua Port Machinery Company, Ltd (ZPMC), Changxing Island **Location:** Shanghai, China**CWI Name:** Sun Bo**CWI Present:** Yes No**Inspected CWI report:** Yes No N/A**Rod Oven in Use:** Yes No N/A**Electrode to specification:** Yes No N/A**Weld Procedures Followed:** Yes No N/A**Qualified Welders:** Yes No N/A**Verified Joint Fit-up:** Yes No N/A**Approved Drawings:** Yes No N/A**Approved WPS:** Yes No N/A**Delayed / Cancelled:** Yes No N/A**Bridge No:** 34-0006**Component:** OBG Fabrication**Summary of Items Observed:**

WELDING INSPECTION REPORT

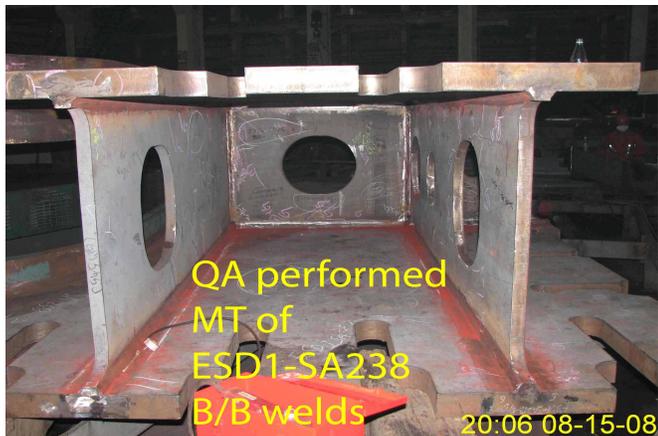
The QA Inspector performed random magnetic particle and visual inspections of tower component ESD1-SA287-weld 18, ESD1-SA238B/B welds 1, 3, 4, 5, 11, 12, 14 and 16. Items observed appear to comply with project specifications. See the TL6028 MT Test Report for additional information.
