DEPARTMENT OF TRANSPORTATION

Contract #: 04-0120F4Cty: SF/ALA Rte: 80 PM: 13.2/13.9File #: 70.28**WELDING INSPECTION REPORT****Resident Engineer:** Pursell, Gary**Address:** 333 Burma Road**City:** Oakland, CA 94607**Report No:** WIR-003899**Date Inspected:** 19-Sep-2008**Project Name:** SAS Superstructure**OSM Arrival Time:** 2300**Prime Contractor:** American Bridge/Fluor Enterprises, a JV**OSM Departure Time:** 700**Contractor:** Japan Steel Works**Location:** Muroran, Japan**CWI Name:** Makhmud Ashadi**CWI Present:** Yes No**Inspected CWI report:** Yes No N/A**Rod Oven in Use:** Yes No N/A**Electrode to specification:** Yes No N/A**Weld Procedures Followed:** Yes No N/A**Qualified Welders:** Yes No N/A**Verified Joint Fit-up:** Yes No N/A**Approved Drawings:** Yes No N/A**Approved WPS:** Yes No N/A**Delayed / Cancelled:** Yes No N/A**Bridge No:** 34-0006**Component:** Tower, Deviation and Jacking Saddles**Summary of Items Observed:**

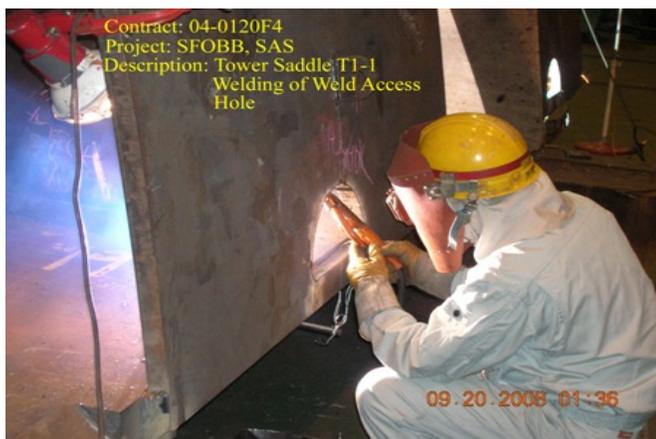
At the start of the shift the QA inspector traveled to the Fabrication Shop # 4 to observe the scheduled shop welding, QC inspection and the verification of the Alternating Current (AC) welding parameters on the structural steel plate components for the Tower Saddle identified as T1-1. The welding was performed, after the removal of the run-off plates, at the inside edge face of the weld access hole located at the end rib plate to stem plate connection. The welding was performed by Japan Steel Works, Ltd. (JSW) welding personnel Hidetaka Nishikawa ID 08-5162. The welder, Hidetaka Nishikawa utilized the Welding Procedure Specification (WPS) SJ-3012-11, which is pending approval at this time and was also used by the QC inspector as a reference during verification of the welding parameters. The welding was performed on the end rib plate to stem plate connection identified as 7Y-5V (1-3) and was performed in the horizontal (2F) position.

The QA inspector also observed JSW welding personnel, Kouzo Kobayashi ID 08-5023 removing the run off extension plates on the structural steel connections identified as 7Y-5V (1-2). Kouzo Kobayashi utilized the manual air carbon arc cutting process to perform this task.

See Weld Joints in Progress Inspected, below, in regards to QA observation of the welding parameters recorded during this shift on this date. The following digital photographs illustrate the observations of the activities performed on this date.
