**DEPARTMENT OF TRANSPORTATION**

Contract #: 04-0120F4Cty: SF/ALA Rte: 80 PM: 13.2/13.9File #: 69.28**WELDING INSPECTION REPORT****Resident Engineer:** Pursell, Gary**Address:** 333 Burma Road**City:** Oakland, CA 94607**Report No:** WIR-003916**Date Inspected:** 17-Sep-2008**Project Name:** SAS Superstructure**OSM Arrival Time:** 1400**Prime Contractor:** American Bridge/Fluor Enterprises, a JV**OSM Departure Time:** 2300**Contractor:** Zhenhua Port Machinery Company, Ltd (ZPMC), Changxing Island **Location:** Shanghai, China**CWI Name:** Chen Chih-Ming**CWI Present:** Yes No**Inspected CWI report:** Yes No N/A**Rod Oven in Use:** Yes No N/A**Electrode to specification:** Yes No N/A**Weld Procedures Followed:** Yes No N/A**Qualified Welders:** Yes No N/A**Verified Joint Fit-up:** Yes No N/A**Approved Drawings:** Yes No N/A**Approved WPS:** Yes No N/A**Delayed / Cancelled:** Yes No N/A**Bridge No:** 34-0006**Component:** Various (see below)**Summary of Items Observed:**

# WELDING INSPECTION REPORT

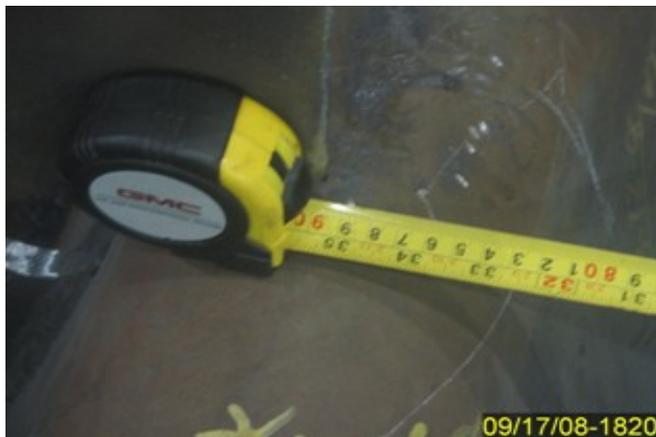
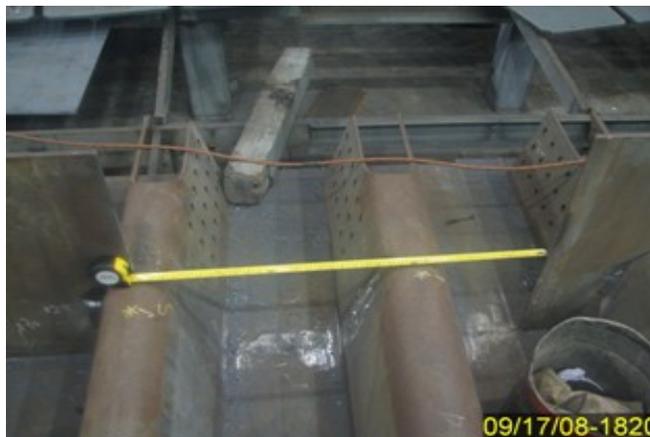
QA observed that ZPMC personnel has removed a 900mm section of the external deck panel diaphragm on DP-073-001 without engineering approval in order to repair two Partial Joint Penetration (PJP) u-rib to deck plate welds where crack like indications were previously discovered with Phased Array Ultrasonic Testing (PAUT) by Caltrans QA. The diaphragm was removed in the area of weld joints 001 thru 003. AWS D1.5 2002 paragraph 3.7.5 prohibits the removal of welded members without engineering approval. Paragraphs 3.1.4 and 3.1.5 prohibits the contractor from creating a weld joint that is not specified on the drawings without engineering approval. QA informed ZPMC QC Testino Wang and ABF representative Peter Shaw of an impending incident report concerning this issue. See attached photos.
