Contract #: 04-0120F4Cty: SF/ALA Rte: 80 PM: 13.2/13.9File #: 01.28**WELDING INSPECTION REPORT****Resident Engineer:** Pursell, Gary**Address:** 333 Burma Road**City:** Oakland, CA 94607**Report No:** WIR-000241**Date Inspected:** 26-Jun-2007**Project Name:** SAS Superstructure**OSM Arrival Time:** 630**Prime Contractor:** American Bridge/Fluor Enterprises, a JV**OSM Departure Time:** 1700**Contractor:** American Bridge/Fluor Enterprises, a JV**Location:** Benicia, CA**CWI Name:** Michael Johnson**CWI Present:** Yes No**Inspected CWI report:** Yes No N/A**Rod Oven in Use:** Yes No N/A**Electrode to specification:** Yes No N/A**Weld Procedures Followed:** Yes No N/A**Qualified Welders:** Yes No N/A**Verified Joint Fit-up:** Yes No N/A**Approved Drawings:** Yes No N/A**Approved WPS:** Yes No N/A**Delayed / Cancelled:** Yes No N/A**Bridge No:** 34-0006**Component:** Procedure Qualification Record (PQR) Test**Summary of Items Observed:**

WELDING INSPECTION REPORT

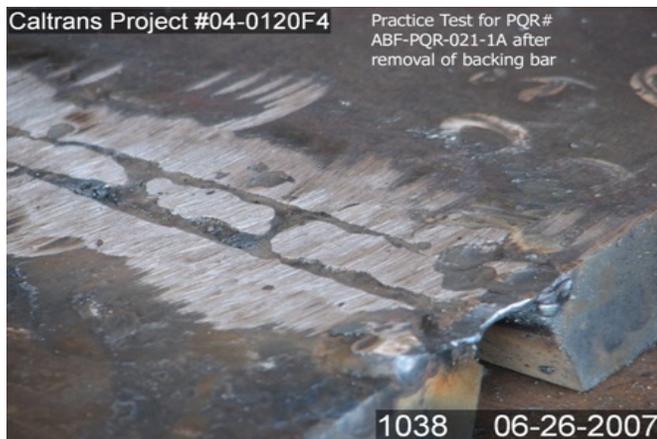
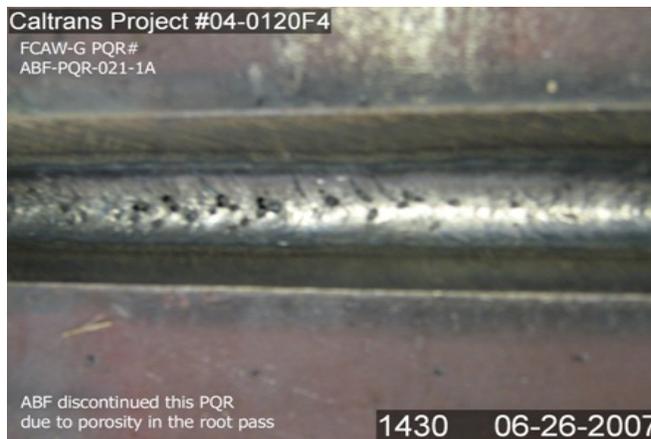
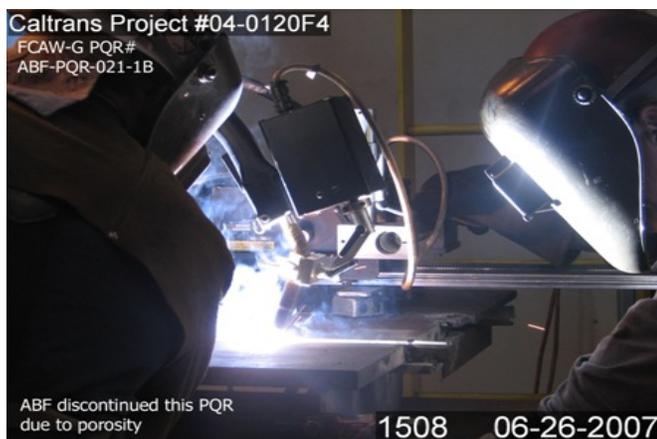
The QA Inspector witnessed the completion of the second attempt of a PQR Test, which was previously identified as ABF-PQR-022-2. This PQR is now identified as ABF-PQR-022-2A. This PQR test is being attempted using the flux-cored arc welding (FCAW) process and a mechanical device that travels on a magnetic track. Welder Dan Gordon deposited three weld passes on this date. For specific welding parameters recorded during this PQR and digital photographs that support these observations, see Caltrans Welding Witness Report, TL-6032 generated on this date.

The QA Inspector witnessed the beginning of the second attempt of a PQR test, which was previously identified as ABF-PQR-021-1. This PQR is now identified as ABF-PQR-021-1A. Welder Dan Gordon deposited the root pass only on this date. After a visual inspection of the root pass, Quality Control Representative Mr. Michael Johnson observed excessive amounts of porosity in the root pass. At that time, ABF Representative Mr. Rick Clayborn elected to discontinue this PQR attempt and begin a third attempt at the same PQR. This PQR was identified as ABF-PQR-021-1B. Welder Dan Gordon deposited six passes on this PQR. After periodic visual inspections and excessive grinding to remove porosity, Mr. Clayborn elected to discontinue this PQR also.
