Contract #: 04-0120F4Cty: SF/ALA Rte: 80 PM: 13.2/13.9File #: 69.28**WELDING INSPECTION REPORT****Resident Engineer:** Pursell, Gary**Address:** 333 Burma Road**City:** Oakland, CA 94607**Report No:** WIR-000246**Date Inspected:** 01-Jul-2007**Project Name:** SAS Superstructure**OSM Arrival Time:** 830**Prime Contractor:** American Bridge/Fluor Enterprises, a JV**OSM Departure Time:** 1730**Contractor:** Zhenhua Port Machinery Company, Ltd (ZPMC), Changxing Island **Location:** Shanghai, China**CWI Name:****CWI Present:** Yes No**Inspected CWI report:** Yes No N/A**Rod Oven in Use:** Yes No N/A**Electrode to specification:** Yes No N/A**Weld Procedures Followed:** Yes No N/A**Qualified Welders:** Yes No N/A**Verified Joint Fit-up:** Yes No N/A**Approved Drawings:** Yes No N/A**Approved WPS:** Yes No N/A**Delayed / Cancelled:** Yes No N/A**Bridge No:** 34-0006**Component:** Closed Rib Forming Demonstration**Summary of Items Observed:**

Item	Description	WBS	Dwg No.	Status
1	Closed Rib Demonstration Pneumatic Milling	N/A	N/A	N/A
	Closed Rib Demonstration-Closed Rib-Pneumatic Machine Milling of Hand Hole Edge

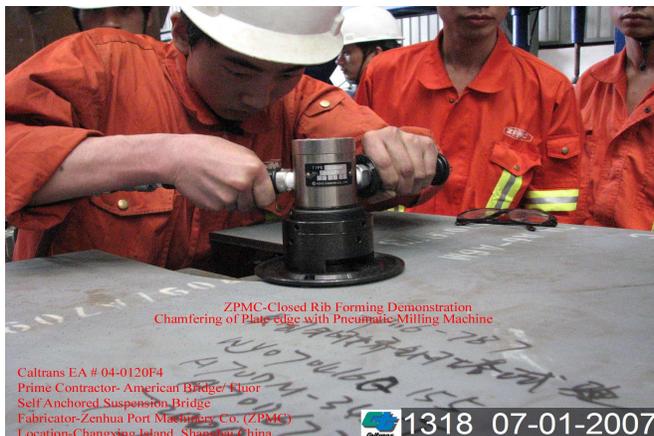
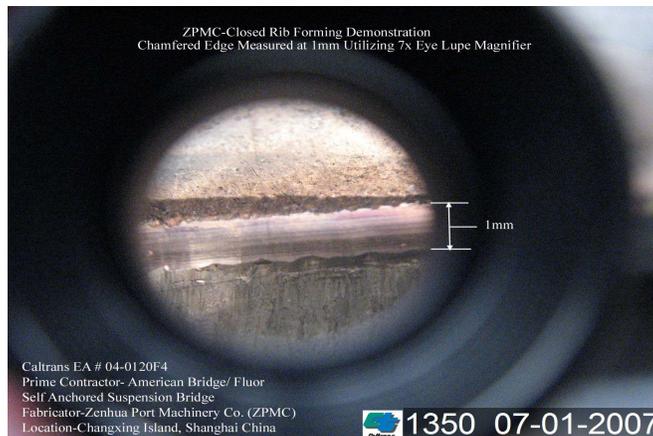
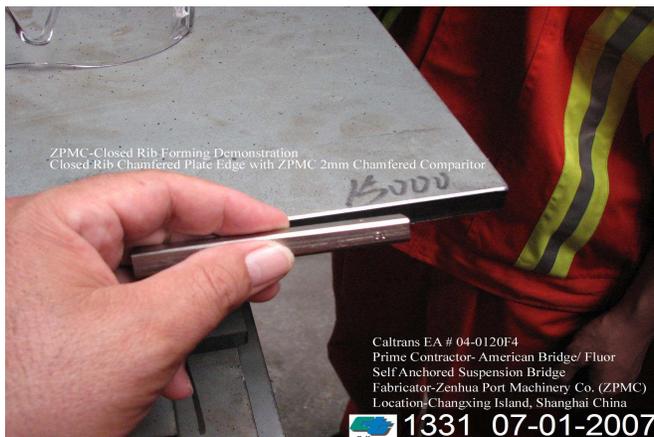
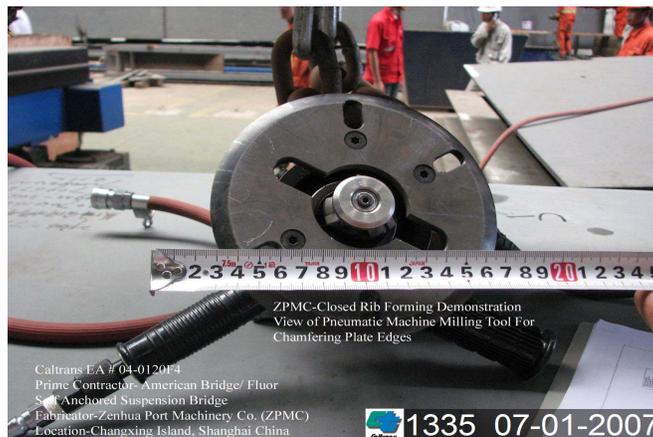
The Caltrans QA Inspector was present as requested by ABF and also ZPMC for the purpose of observing fabrication sequences prior to the closed rib forming demonstration. The Caltrans QA Inspector observed that there is a number of ZPMC representatives present along with ABF representative Mr. Danny McDonald. The Caltrans QA Inspector observed that the first step of the closed rib preparation is the chamfering of the hand hole for the bolt connection. A ZPMC worker was observed utilizing a pneumatic machine milling device for the purpose of chamfering the edge located at the hand hole of the closed rib number one (1). This chamfering of the hand hole edge and also the extreme end of the closed rib is required to be chamfered to a 2mm radius as described within the ZPMC fabrication figure 2.3.

At the completion of the machine milling operation the Caltrans QA Inspector questioned the ZPMC representatives and also the ABF representative as to how the chamfered edge was being measured to determine if the 2mm radius had been accomplished. After a period of time, ZPMC produced a stainless steel block that simulates a 1mm and also a 2mm radius. The Caltrans QA Inspector observed that the use of this ZPMC chamfering comparator is difficult to utilize as a comparator for the actual machine milled plate edge. The Caltrans QA Inspector utilized a 7x eye Lupe

magnifier to measure the chamfered edge and identified that the chamfered edge was only 1mm. This measurement was confirmed by various representatives of ZPMC. The ABF representative did not participate in measuring of the chamfered edge utilizing the magnifier. Included below are digital pictures that support these observations.

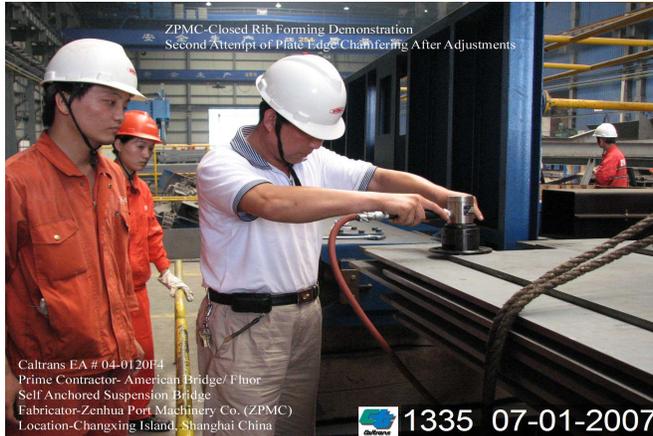
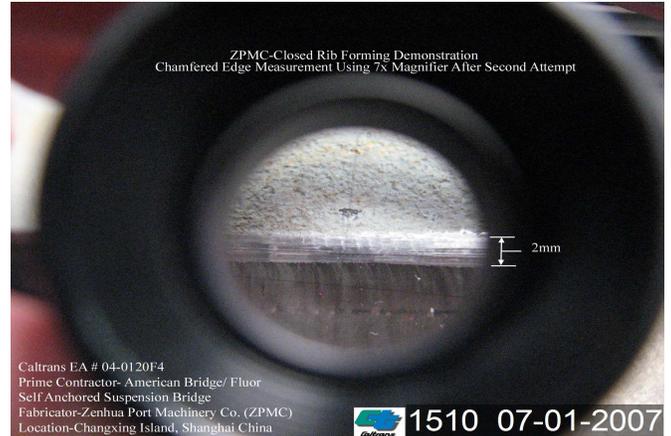
2 Closed Rib Demonstration-2nd Attempt for Pneumatic Milling N/A N/A

Closed Rib Demonstration-2nd Attempt Closed Rib-Pneumatic Machine Milling of Hand Hole Edge

The Caltrans QA Inspector observed that a ZPMC supervisor performed adjustments to the pneumatic machine milling device. At the completion of these adjustments the ZPMC supervisor performed plate edge chamfering on several scrap plate edges to measure his adjustments. After several plate chamfering attempts, the ZPMC supervisor was comfortable with the results and proceeded to perform the machine milling of the closed rib edge opposite the first attempt. At the conclusion of this machine milling, the Caltrans QA Inspector and several ZPMC representatives performed a measurement of the chamfered edge utilizing a 7x magnifying eye Lupe. The Caltrans QA Inspector and the ZPMC representatives confirmed a 2mm chamfer with the new machine milling adjustments. The initial machine milling performed at the hand hole for the bolt connection area was also remilled with the new adjustments. This subsequent machine milling also was measured with the 7x magnifier and observed as having a 2mm radius. The following digital pictures support these observations.

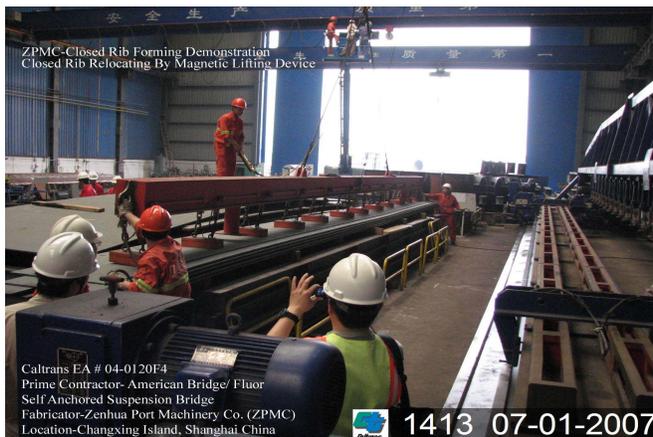
| 3 | Relocating of Closed Rib Plate

Closed Rib Forming Demonstration-Relocating of Closed Rib Plate to Plate Edge Milling Machine | N/A | N/A | N/A |

The Caltrans QA Inspector observed that ZPMC is utilizing a magnetic lifting device for the relocating of the first closed rib scheduled for use of the closed rib demonstration forming operation. Included below is a digital picture of this observation.

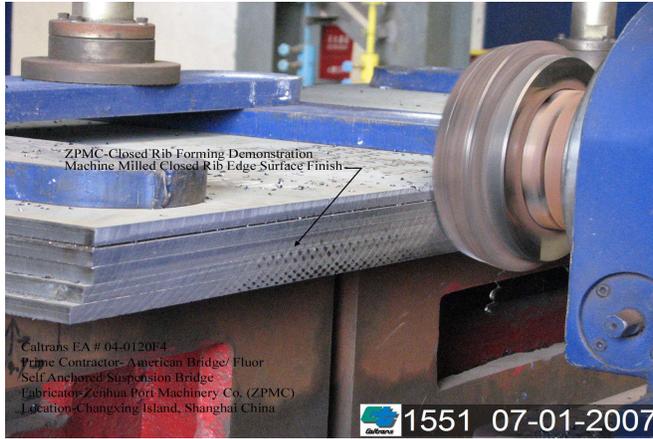
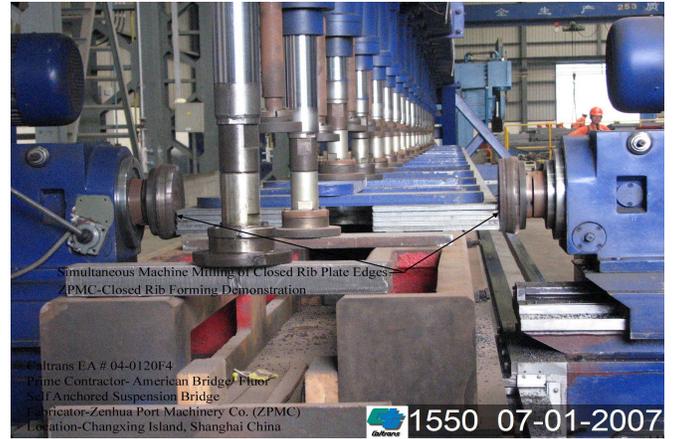
| 4 | Closed Rib-Longitudinal Plate Milling Machine

Closed Rib Forming Demonstration-Closed Rib Longitudinal Plate Edge Milling Machine | N/A | N/A | N/A |

After approximately 2 hours the Caltrans QA Inspector observed the second step of ZPMC's closed rib forming demonstration. This step was observed as the relocating of five closed rib plates that have been stacked in position for milling of the longitudinal closed rib edges. The five closed rib plates are held in position utilizing hydraulic presses and also plate softeners that separate the hydraulic press heads from the stacked closed ribs. The Caltrans QA Inspector observed the machine milling of the five stacked closed rib plates. There are two (2) milling heads that run simultaneously and parallel on a track along the closed rib longitudinal edges. ZPMC advised that this milling operation of the closed rib longitudinal plate edges will consume approximately two (2) hours. This operation was not completed during the Caltrans QA Inspectors presence. Included below are digital pictures that support this observation.
