Contract #: 04-0120F4Cty: SF/ALA Rte: 80 PM: 13.2/13.9File #: 01.28**WELDING INSPECTION REPORT****Resident Engineer:** Pursell, Gary**Address:** 333 Burma Road**City:** Oakland, CA 94607**Report No:** WIR-000256**Date Inspected:** 05-Jul-2007**Project Name:** SAS Superstructure**OSM Arrival Time:** 630**Prime Contractor:** American Bridge/Fluor Enterprises, a JV**OSM Departure Time:** 1700**Contractor:** American Bridge/Fluor Enterprises, a JV**Location:** Benicia, CA**CWI Name:** Michael Johnson**CWI Present:** Yes No**Inspected CWI report:** Yes No N/A**Rod Oven in Use:** Yes No N/A**Electrode to specification:** Yes No N/A**Weld Procedures Followed:** Yes No N/A**Qualified Welders:** Yes No N/A**Verified Joint Fit-up:** Yes No N/A**Approved Drawings:** Yes No N/A**Approved WPS:** Yes No N/A**Delayed / Cancelled:** Yes No N/A**Bridge No:** 34-0006**Component:** Procedure Qualification Record (PQR) Test**Summary of Items Observed:**

WELDING INSPECTION REPORT

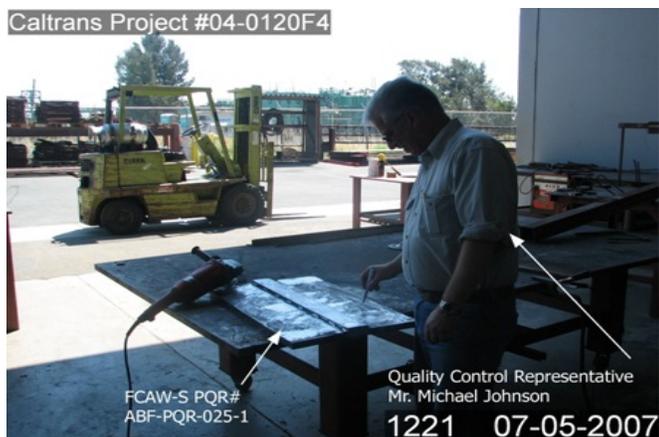
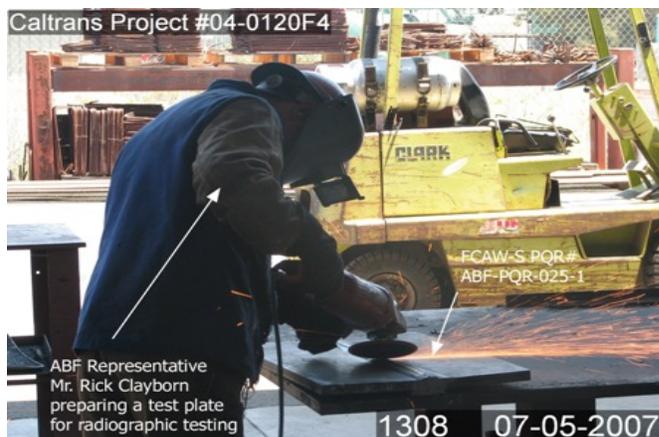
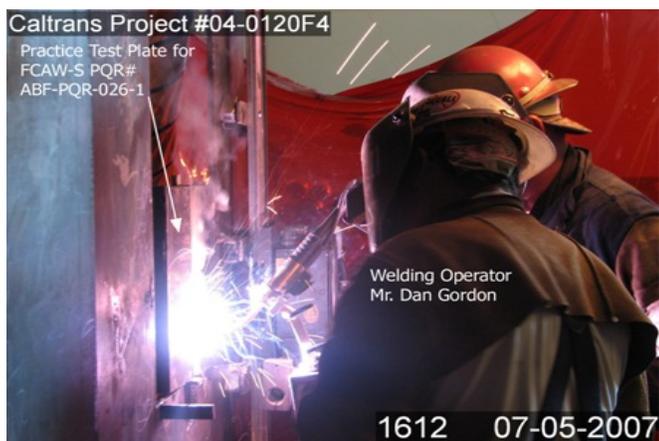
The QA Inspector witnessed the completion of the first attempt of a PQR Test identified as ABF-PQR-025-2. This PQR test is being attempted using the flux-cored arc welding (FCAW) process and a mechanical device that travels on a magnetic track. Welder Dan Gordon deposited eight weld passes on this date. For specific welding parameters recorded during this PQR and digital photographs that support these observations, see Caltrans Welding Witness Report, TL-6032 generated on this date.

The QA Inspector observed ABF personnel using practice test plates to establish root and filler pass settings in the vertical position for the next PQR test plate which will be identified as ABF-PQR-026-1.
