DEPARTMENT OF TRANSPORTATION

Contract #: 04-0120F4Cty: SF/ALA Rte: 80 PM: 13.2/13.9File #: 69.28**WELDING INSPECTION REPORT****Resident Engineer:** Pursell, Gary**Address:** 333 Burma Road**City:** Oakland, CA 94607**Report No:** WIR-000261**Date Inspected:** 20-Jun-2007**Project Name:** SAS Superstructure**OSM Arrival Time:** 800**Prime Contractor:** American Bridge/Fluor Enterprises, a JV**OSM Departure Time:** 1730**Contractor:** Zhenhua Port Machinery Company, Ltd (ZPMC), Changxing Island **Location:** Shanghai, China**CWI Name:** Mr. Zhou Daging**CWI Present:** Yes No**Inspected CWI report:** Yes No N/A**Rod Oven in Use:** Yes No N/A**Electrode to specification:** Yes No N/A**Weld Procedures Followed:** Yes No N/A**Qualified Welders:** Yes No N/A**Verified Joint Fit-up:** Yes No N/A**Approved Drawings:** Yes No N/A**Approved WPS:** Yes No N/A**Delayed / Cancelled:** Yes No N/A**Bridge No:** 34-0006**Component:** Welder/ Welding Operator Qualification Test**Summary of Items Observed:**

Caltrans Quality Assurance (QA) Inspector Robert Cuellar is present at the fabrication facility of Zhenhua Port Machinery Company (ZPMC), LTD for the purpose of monitoring activities relative t

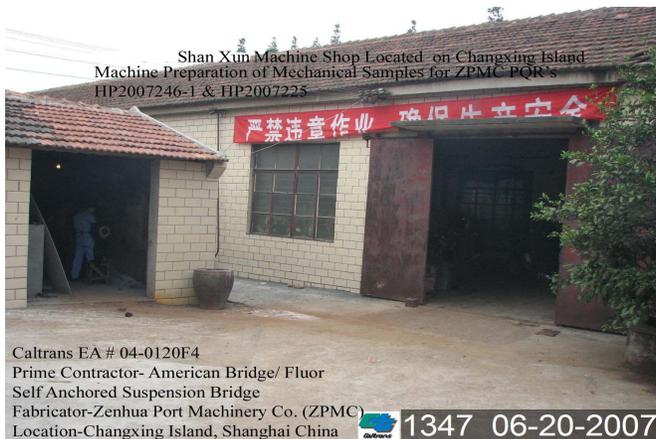
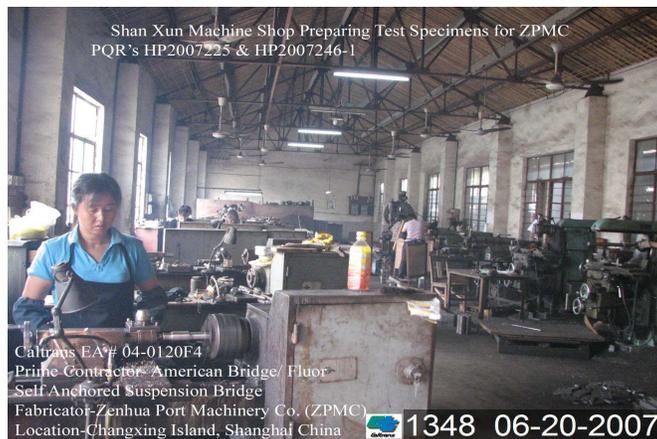
Item	Description	WBS	Dwg No.	Status
1	Machine Shop For PQR Specimens	N/A	N/A	N/A

Machine shop located at a location In Changxing Island that is away from the ZPMC fabrication facility.

The Caltrans QA Inspector traveled by shuttle bus supported by ZPMC. The Caltrans QA Inspector was accompanied by ZPMC representatives Mr. Xu Jun and Ms. Zhou Chun Mei. The purpose of this trip was to observe the preparing of machined specimens for ZPMC PQRs identified as HP2007225 & HP2007246-1. The Caltrans QA Inspector observed that this machine shop is located in an area that appears to be residences for living. The following digital pictures capture a portion of the Caltrans QA Inspector's observations.

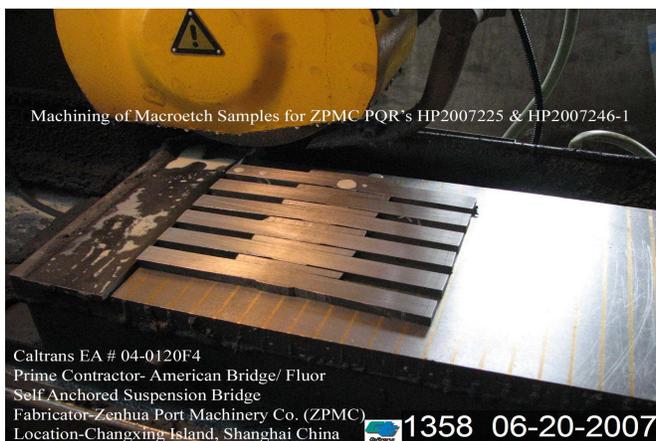
2	Machining Of Macroetch Specimens	N/A	N/A	N/A
---	----------------------------------	-----	-----	-----

The Caltrans QA Inspector observed that the machine shop is in the process of preparing, reduced section tension specimens, standard all weld metal tension specimens, side bend specimens, charpy vee notch specimens and also macroetch test specimens. Based on random observations and random dimensional verification performed utilizing a digital caliper it appears that the preparation of the test specimens for PQR tests identified as HP2007225 and HP2007246-1 is progressing in general compliance with AWS D1.5 (2002) Figures 5.9, 5.10, 5.11, 5.13 and also macroetch test sample criteria.

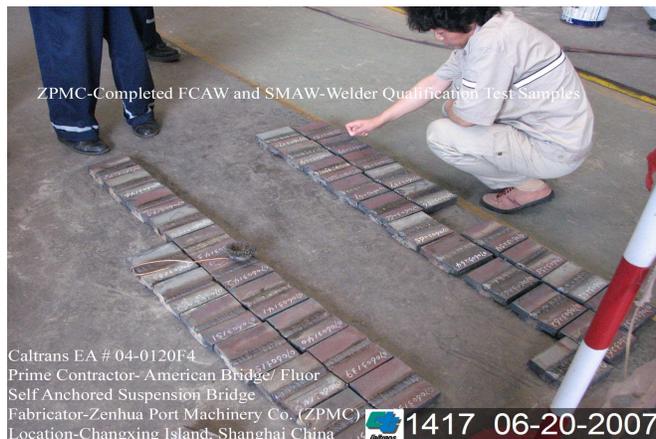
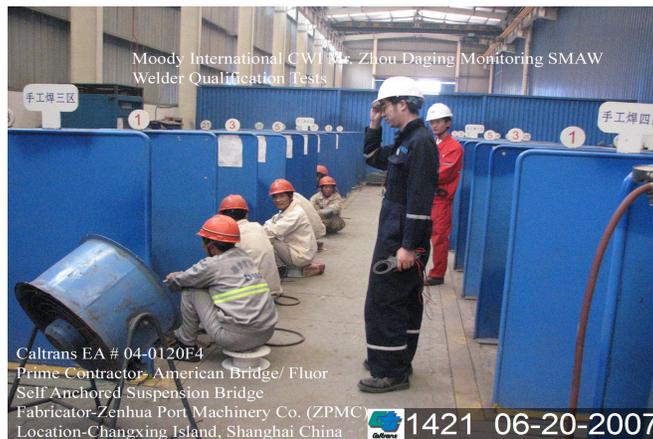
4	Welder/ Welding Operator Qualification Testing	N/A	N/A	N/A
---	--	-----	-----	-----

The Caltrans QA Inspector was accompanied by ZPMC representative Mr. Xu Jun, ABF representatives Mr. Kevin Dye and Dustin Brungardt for the purpose of traveling to a remote ZPMC location on Changxing Island for the continuing observation of in process Welder and Welding Operator qualification tests. As previously addressed this test facility of ZPMC is an established Welder/ Welding Operator qualification test facility at an area located approximately 15 to 20 minutes traveling by car from the main facility in Changxing Island. The Caltrans QA Inspector observed numerous Welder's and Welding Operator's in process of attempting qualification utilizing the shielded metal arc welding (SMAW) process, the flux cored arc welding (FCAW) process and also the submerged arc welding (SAW) process. The Caltrans QA Inspector observed that there are Moody International Representatives who are performing the monitoring of these Welder/Welding Operator Qualification tests. The Caltrans QA Inspector observed that there is a Moody International Certified Welding Inspector (CWI) identified as Mr. Zhou Daging with

three assistants that are monitoring the Welder and Welding Operator qualification testing. Based on information provided by Mr. Zhou Daging there are eighteen (18) welders attempting qualification testing utilizing the flux cored arc welding (FCAW) process, nineteen (19) are attempting qualification testing utilizing the shielded metal arc welding process and two (2) are attempting welder operator qualification utilizing the submerged arc welding (SAW) process. These tests are all being attempted for qualification for unlimited thickness. Below are digital pictures of the Caltrans QA Inspector's observation of the activities being performed.

ZPMC representatives have advised the Caltrans QA Inspector that subsequent radiographic testing will be performed of the welder/welding operator qualification test plates that are visually compliant.

Based on random observations it appears that the observed welder/ welding operator qualification testing being performed is progressing in general compliance with AWS D1.5 (2002).
